Technical Service Bulletin

STAINS FOUND ON PAINT DURING PDI

Bulletin No.: 09-008/20

Last Issued: 01/13/2020

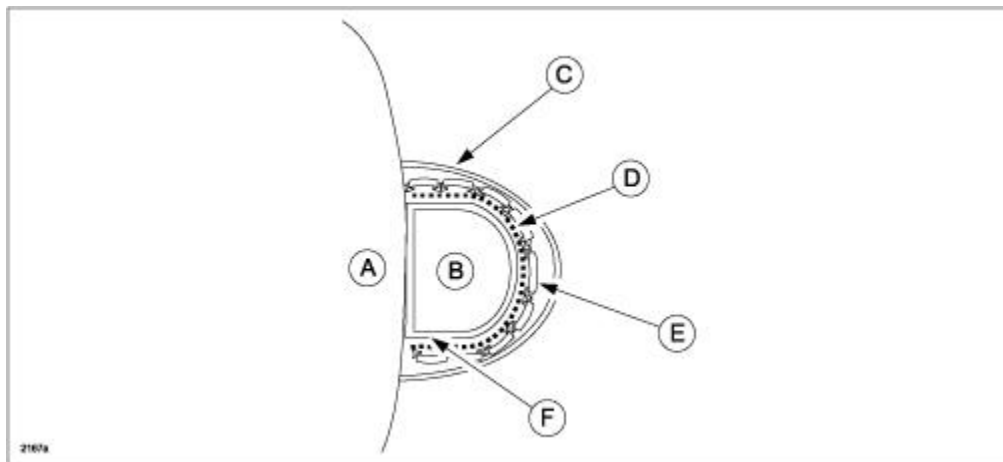
Some vehicles may experience stains appearing on the hood, roof and/or trunk of the vehicle. This concern is most likely to be found in a cold weather areas just after the RAPGARD is removed at PDI. This may be caused by moisture which has been trapped and condensed between the paint and the RAPGARD. These types of stains can be removed with a heat gun or an infrared drier.

2. Insulate all plastic and rubber parts (as shown below) using heat insulation materials (C ~ F) prior to beginning the application of heat.

- Since this repair procedure requires the use of heat from a heat gun or infrared drier, be sure to insulate all rubber or plastic parts which are easily affected by heat from near the affected stain area.
- Use extreme care to ensure the top coat surface temperature stays below 284°F (140°C).
- To protect materials inside the cabin area (i.e. carpet, seats, etc.), also place insulation over the glass as necessary.
