Service Information

Category R	Repair Guidance	Ref. No. R072/13G	Page 1 of 5
Coverage <input type="checkbox"/> Distributor only <input checked="" type="checkbox"/> Please inform your dealers		Date Issued September 19, 2013	
Please convey this information to your <input type="checkbox"/> Director <input checked="" type="checkbox"/> General Manager <input checked="" type="checkbox"/> Warranty Dept. <input checked="" type="checkbox"/> Parts Dept. <input checked="" type="checkbox"/> Training Dept. <input checked="" type="checkbox"/> Field Rep.		Date Revised November 15, 2017	
Applicable Model Mazda3 (BM/BN), Mazda6 (GJ/GL) and CX-5 (KE/KF)		Applicable Countries or Specifications Worldwide (except North America)

Subject: Creaking Noise from Front Lower Arm Bushing when driving over bumps in wet condition

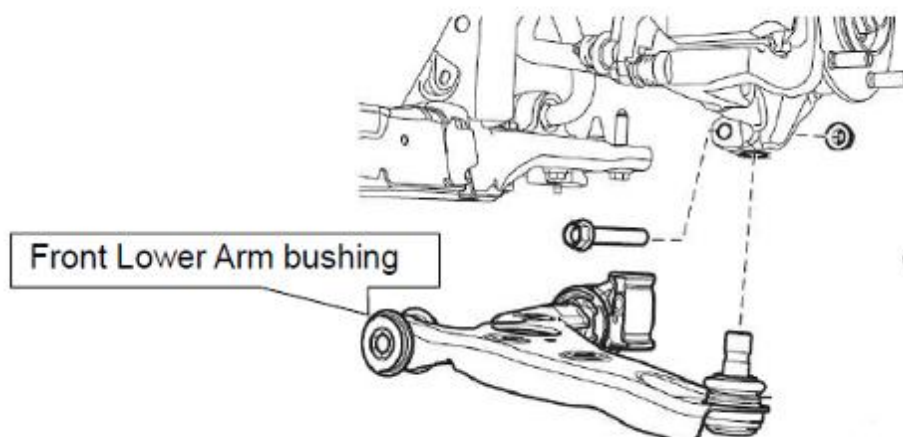
The Front Lower Arm Bushing is making a stick-slip noise in wet road condition.

The surface treatment of the front lower arm bushing has been further improved to reduce friction and prevent stick-slip noise.

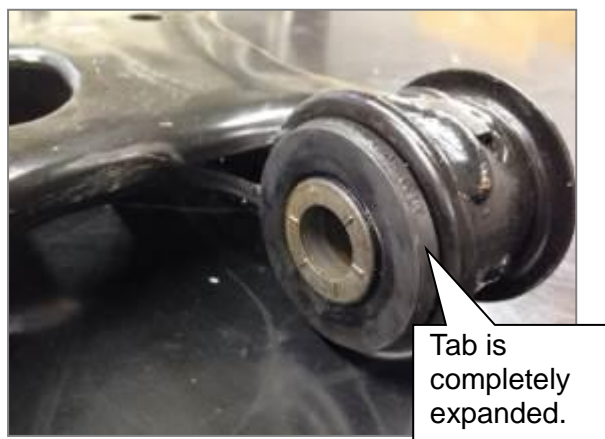
CAUTION: Make sure that the bushing has been properly inserted by checking that the tab of the bushing is completely expanded as shown in the OK illustration.

OK: Properly installed

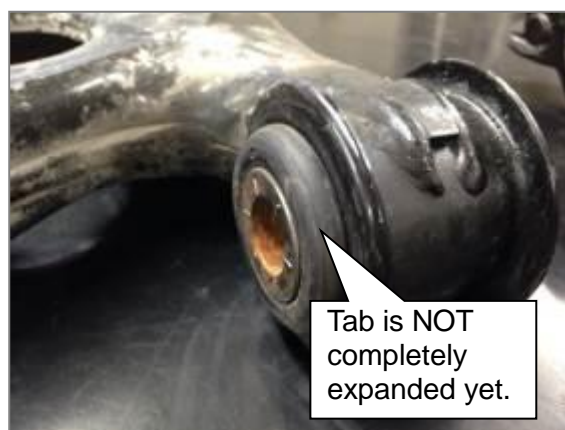
NG: Improperly installed
