<b>Subject:</b>  <b>UNUSUAL ENGINE NOISE AFTER A COLD ENGINE START</b>	<b>Bulletin No:</b> 01-018/16  <b>Last Issued:</b> 10/25/2016
--	---

2016-2017 Mazda2	2014-2017 Mazda6	2013-2016 CX-5	2016-2017 MX-5
2014-2017 Mazda3	2016-2017 CX-3	2016 CX-9

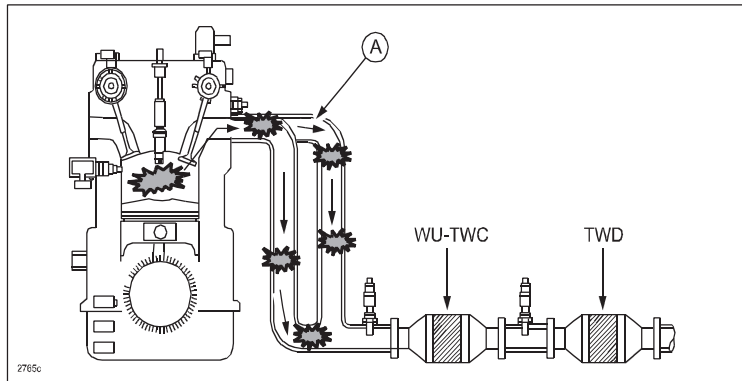
AWS burns fuel inside the exhaust manifold (A) to quickly warm up the catalytic converter. The customer may identify the burning sound as an unusual noise.
