Service Information

Category F	Technical	Ref. No. E023/17	Page 1 of 4
Coverage <input type="checkbox"/> Distributor only <input checked="" type="checkbox"/> Please inform your dealers		Date Issued December 13, 2017	
Please convey this information to your <input type="checkbox"/> Director <input checked="" type="checkbox"/> General Manager <input checked="" type="checkbox"/> Warranty Dept. <input checked="" type="checkbox"/> Parts Dept. <input checked="" type="checkbox"/> Training Dept. <input checked="" type="checkbox"/> Field Rep.		Date Revised	
Applicable Model All Models equipped with SKYACTV-G Engines of Direct Fuel Injection System		Applicable Countries and/or Vehicle Specifications Worldwide

Subject: Engine Oil Dilution with Fuel

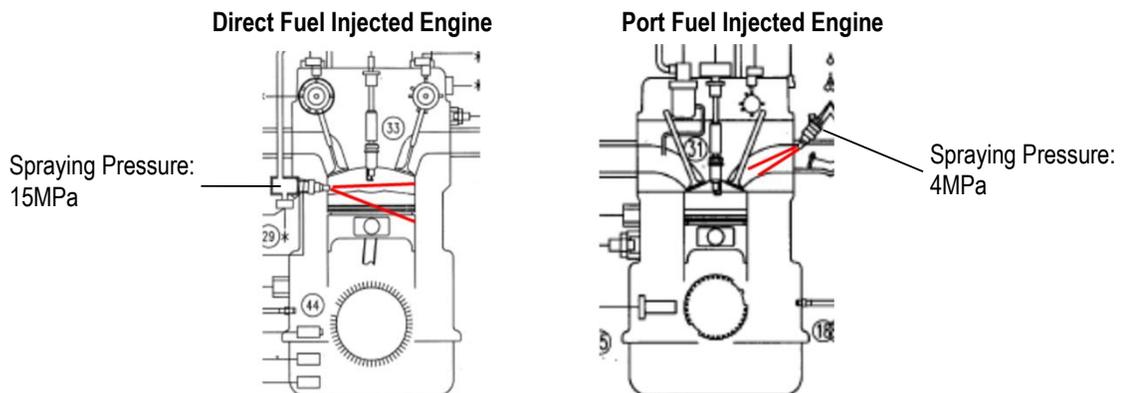
A direct fuel injected gasoline engine is designed that high-pressurized fuel is injected directly into the combustion chamber, which may cause the fuel to adhere to the cylinder wall. The fuel is then scraped by the piston, flows down into the crankcase and mixes with the engine oil causing "an engine oil dilution with fuel".

On the contrary for a port fuel injected gasoline engine, a fuel is injected toward the upstream of the intake valve and so it is unlikely to have fuel adhering to cylinder walls.

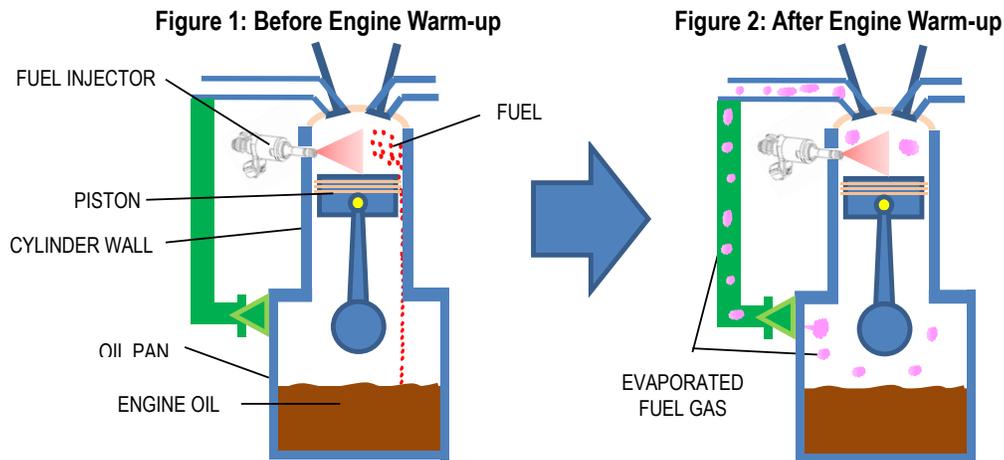
Figure 1: While the engine is not warmed up yet, fuel flows down between the piston and cylinder wall and enters in the oil pan mixing with the engine oil.

Figure 2: After the engine is warmed up, fuel content in the engine oil evaporates by engine operating temperatures and the evaporated fuel gas is sucked into the combustion chamber and burnt off. At this time, the amount of fuel injected by fuel injector is adjusted according to the amount of fuel evaporated from the engine oil and entered in the combustion chamber.

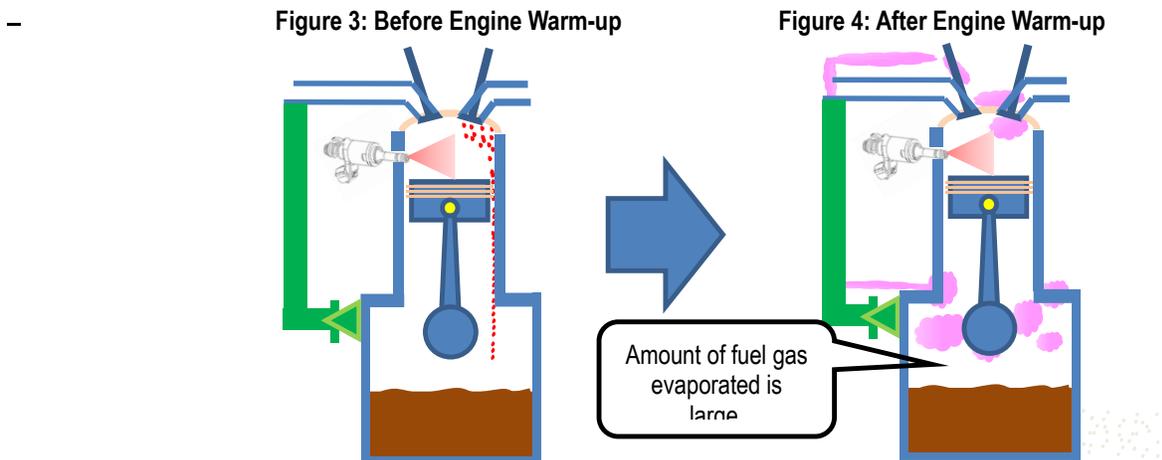
Figure 3: In this case, fuel content in the engine oil does not evaporate actively and so the amount of fuel remaining in the engine oil is increased (Engine oil level is increased).

Figure 4: After the engine is warmed up, a larger amount of fuel content in the engine oil evaporates and is burnt off in the combustion chamber. In this case if the amount of fuel evaporated exceeds the limit that the fuel injector can adjust by changing the injection amount, the system turns on the warning light.

In winter time, if a lot of short trips with the engine running in cool condition, are taken, it causes a condition that an engine oil dilution with fuel is likely to occur resulting in the accelerated engine oil deterioration. Therefore, it is recommended to immediately check and replace the engine oil when the check engine light is illuminated.
