# Service Information

Category <b>S</b>	<b>Repair Guidance</b>	Ref. No. R043/13 <b>C</b>	Page 1 of 7
Coverage <input type="checkbox"/> Distributor only <input checked="" type="checkbox"/> Please inform your dealers		Date Issued June 27, 2013	
Please convey this information to your <input type="checkbox"/> Director <input checked="" type="checkbox"/> General Manager <input checked="" type="checkbox"/> Warranty Dept. <input checked="" type="checkbox"/> Parts Dept. <input checked="" type="checkbox"/> Training Dept. <input checked="" type="checkbox"/> Field Rep.		Date Revised January 17, 2018	
Applicable Model <b>Mazda3 (BM/BN), Mazda6(GJ/GL) and CX-5(KE)</b> with Power Seat		Applicable Countries or Specifications Worldwide

## Subject: Excessive operating noise when sliding front power seat

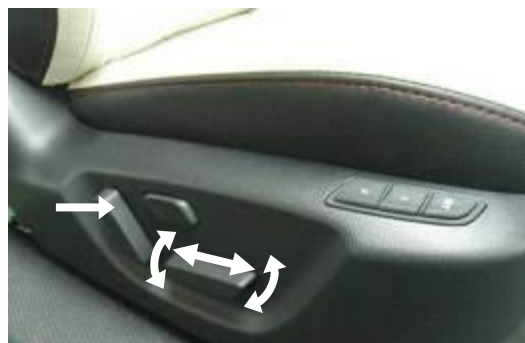
1. Fold the seat back forward by operating the reclining switch. Adjust the seat height and tilt positions upward by operating the switch in order to increase work space.

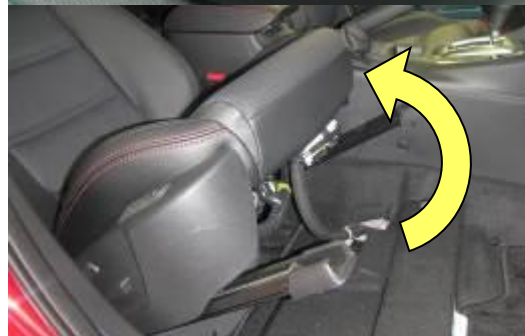
2. Slide the seat to the rear or front, and remove the installation bolts.

**NOTE:** Remove the installation bolts at the rear side first, then at the front.

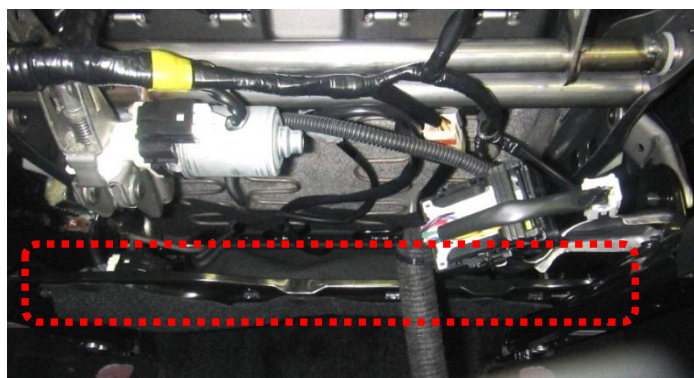
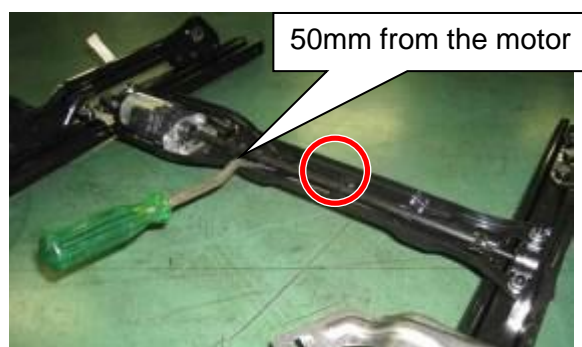
【Seat Frame condition】

4. Insert an appropriate tool (a fastener remover) between the frame (□ part in the left picture below) and the cable. Unfix one of the three fixing points of the cable (shown with ○ in the right picture below) by using the tool as a lever.

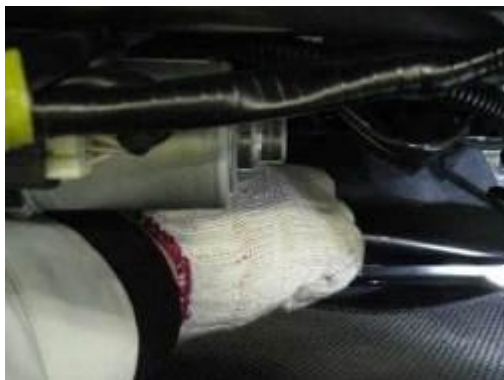
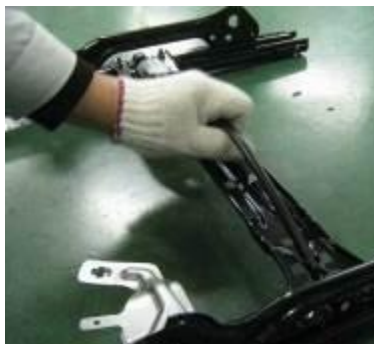
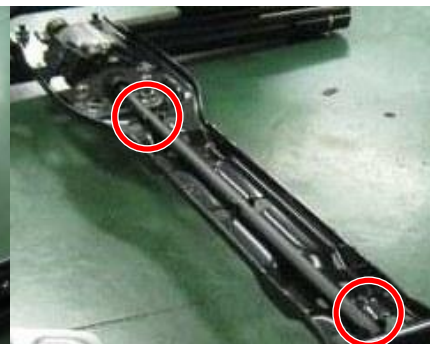
【Seat Frame Picture】

5. Hold the cable by hand and lift it up to release other two fixing points (two of three fixing points shown with ○ in the right picture below).

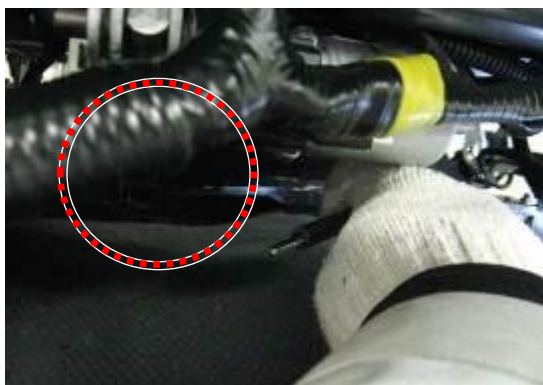
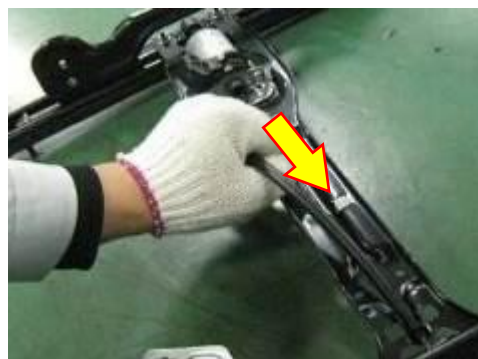
【Seat Frame condition】

6. Pull the cable in the direction of the arrow in the right picture below to remove from the motor.

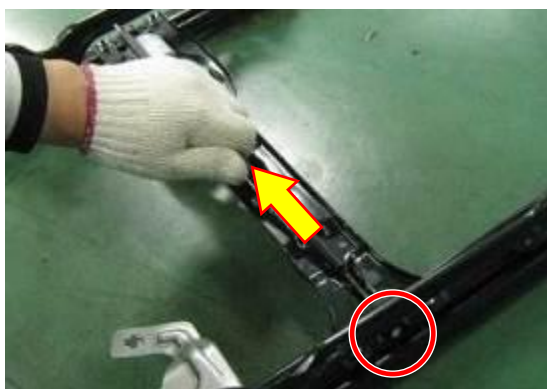
【Seat Frame condition】

7. Pull the cable in the direction of the arrow in the picture below to remove from the gear box.

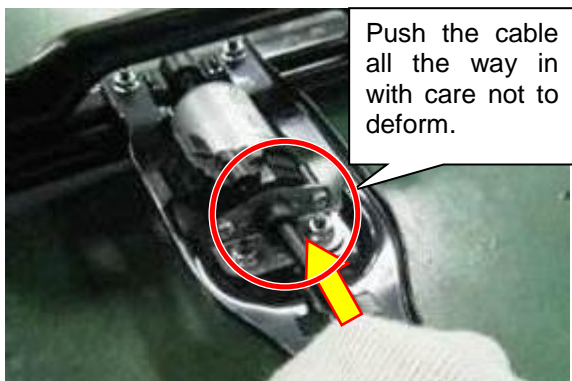
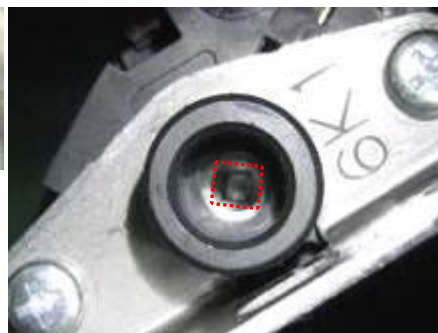
【Seat Frame condition】

8. Align the square tip (□shape) of a new modified cable and the square shape in the motor, and push the cable all the way in.

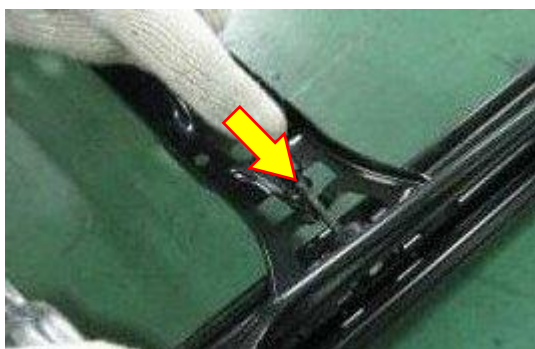
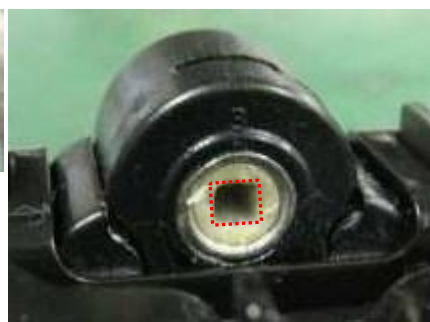
【Seat Frame condition】

9. Align the square tip (□shape) of the cable and the square shape in the gear box, and push the cable all the way in.

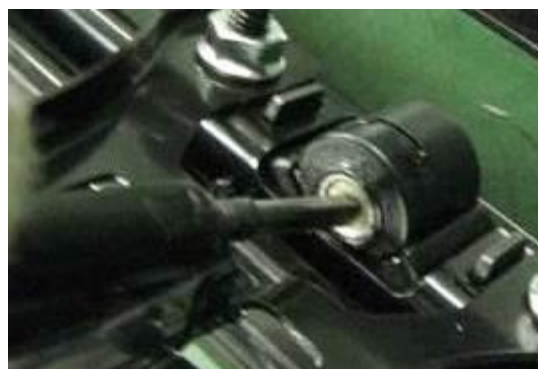
If the cable is bent too much during installation, operation noise may occur later. DO NOT hold around the tip of cable.

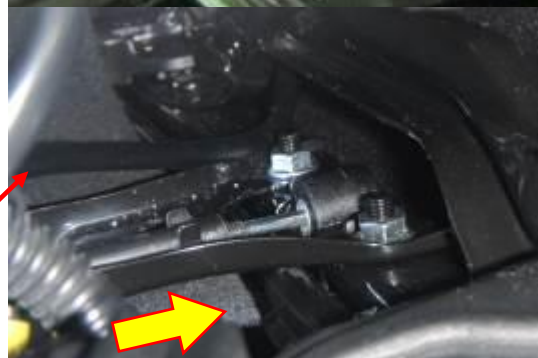
b

- a. If work space is too dark to see properly, use a light to illuminate the spot where the cable should be inserted.
- b. Take caution not to pinch the seat belt buckle harness when installing it.

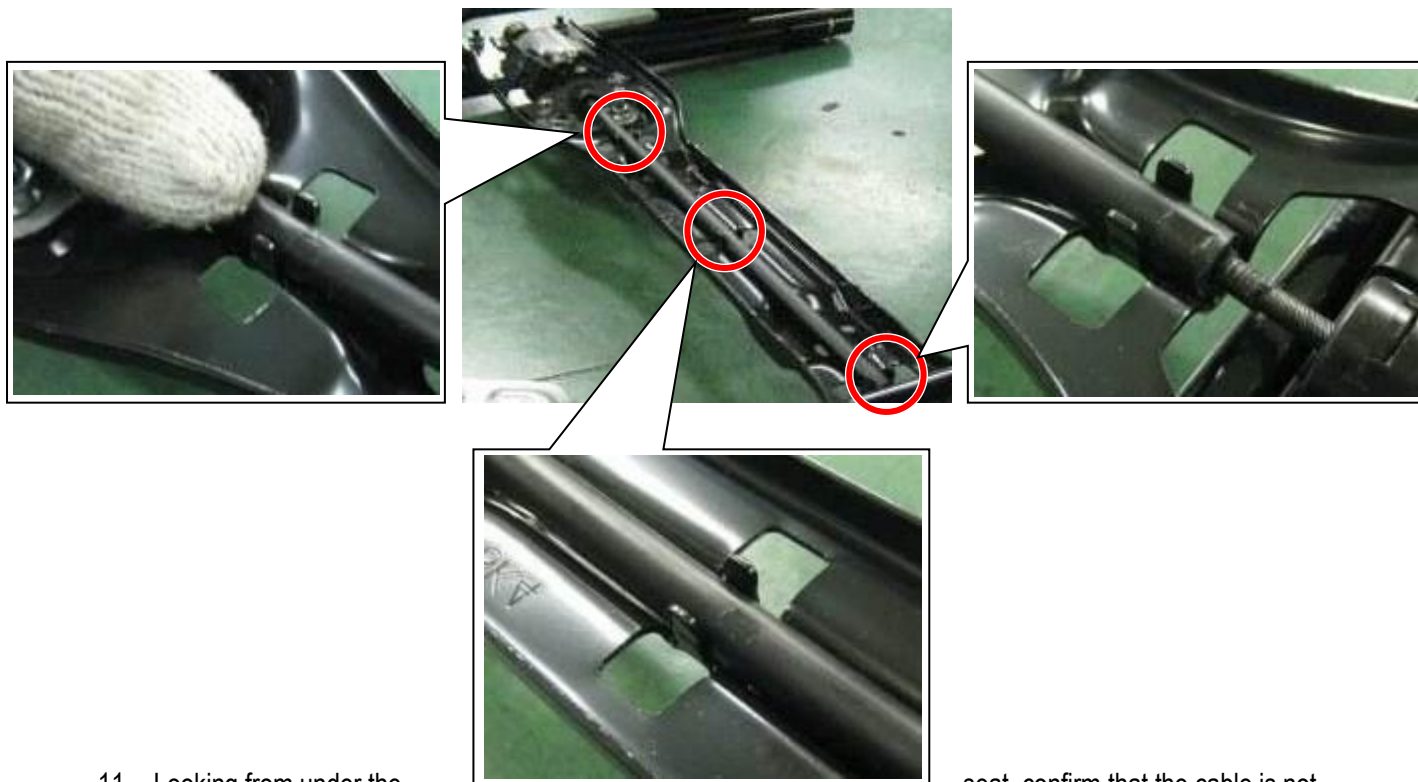
【Seat Frame condition】

10. Press the cable from above with fingers and fix it at the bracket.

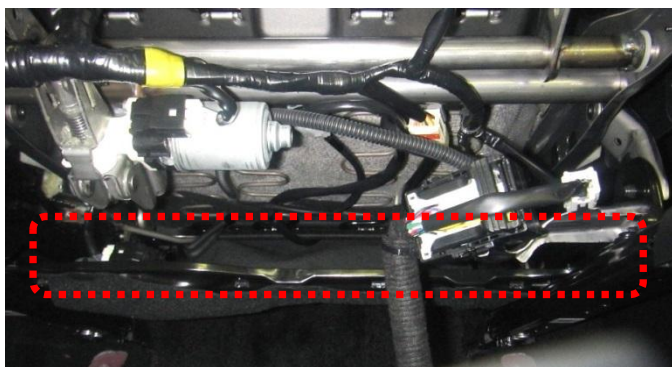
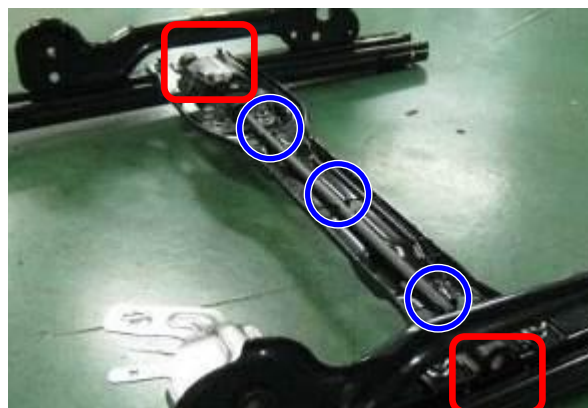
【Seat Frame condition】

11. Looking from under the curved or floated.

seat, confirm that the cable is not

- : Check installation condition of cable to motor and gear box
- : Check fixing condition of cable to frame
