Service Information

Mazda Motor Corporation

Category T	Repair Guidance	Ref. No. R046/17A	Page 1 of 4
Coverage <input type="checkbox"/> Distributor only <input checked="" type="checkbox"/> Please inform your dealers		Date Issued June 28, 2017	
Please convey this information to your <input type="checkbox"/> Director <input checked="" type="checkbox"/> General Manager <input checked="" type="checkbox"/> Warranty Dept. <input checked="" type="checkbox"/> Parts Dept. <input checked="" type="checkbox"/> Training Dept. <input checked="" type="checkbox"/> Field Rep.		Date Revised August 2, 2017	
Applicable Model and Equipment Mazda3 (BN), Mazda6 (GL), CX-3 (DK) and CX-5 (KF)		Applicable Countries and/or Vehicle Specifications Worldwide

Subject: Forward Sensing Camera (FSC) related concerns with DTC C1001:92

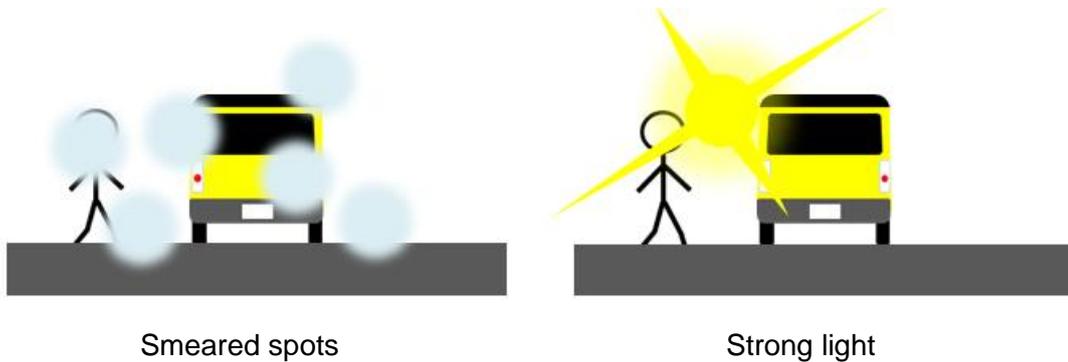
When some obstacles exist between the FSC and the object, the FSC may not be able to detect the object. Dirty windshield, rain and dew drops may be the obstacles for the FSC. Strong light like sun light may also disturb the FSC detection.
