Service Information

Mazda Motor Corporation

Category T	Technical	Ref. No. E006/17	Page 1 of 9
Coverage <input type="checkbox"/> Distributor only <input checked="" type="checkbox"/> Please inform your dealers		Date Issued April 25, 2017	
Please convey this information to your <input type="checkbox"/> Director <input checked="" type="checkbox"/> General Manager <input checked="" type="checkbox"/> Warranty Dept. <input checked="" type="checkbox"/> Parts Dept. <input checked="" type="checkbox"/> Training Dept. <input checked="" type="checkbox"/> Field Rep.		Date Revised	
Applicable Model and Equipment Mazda3 (BN), Mazda6 (GL), CX-3 (DK) and CX-5 (KF) with ALH		Applicable Countries and/or Vehicle Specifications Europe, Australia, New Zealand and 4A

Subject: Adaptive LED headlight warning light illuminates due to poor visibility of FSC

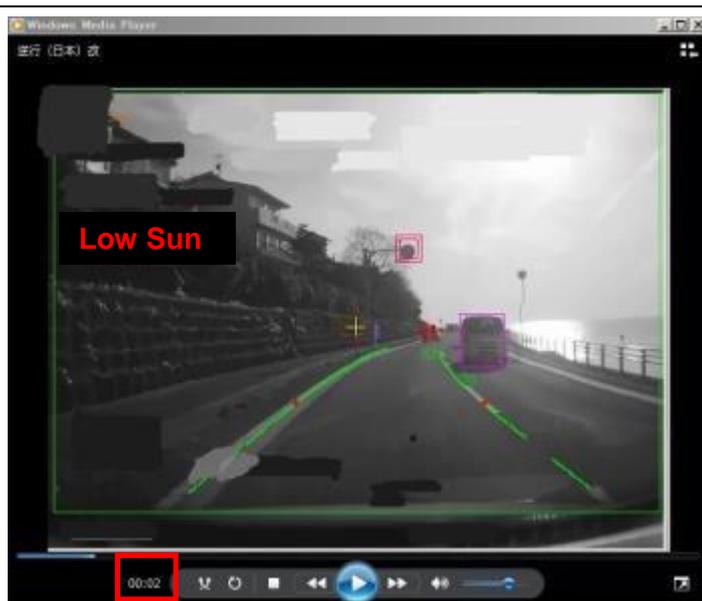
Direct sun light

Between 9-25 sec., “Low Sun” message appears for poor visibility.

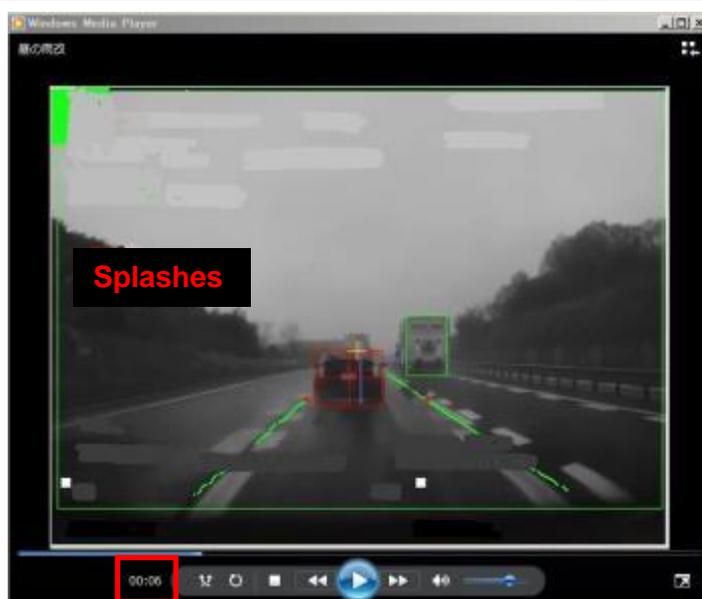
Rain in daytime

Between 6-25 sec., “Splashes” message appears for poor visibility.

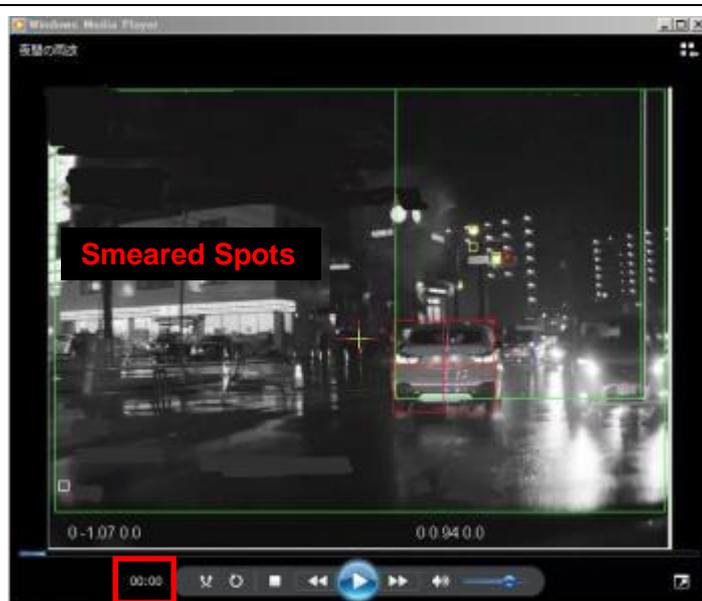
Rain at night

Between 0-25 sec., “Smearred Spots” message appears for poor visibility.

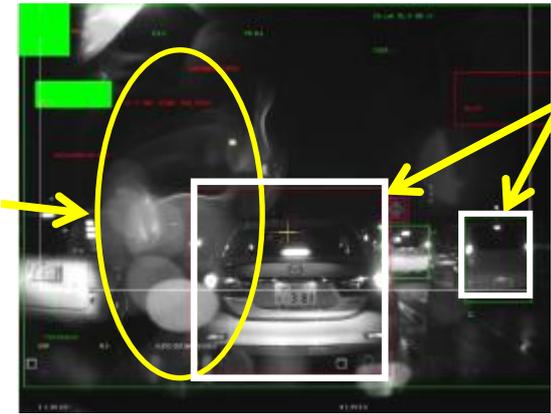
Example of rain at night

<p><u>Visibility detection</u></p> <p>Smear spots caused by rain etc. are detected in the image.</p> <p>>>> The control may be deactivated.</p>

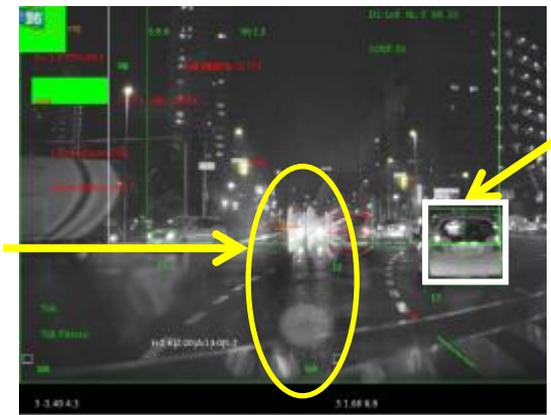
<p><u>Object recognition</u></p> <p>Object recognition and distance calculation continue.</p>
<p><u>Visibility detection</u></p> <p>Smear spots caused by rain etc. and diffused reflection of oncoming headlights are detected in the image.</p> <p>>>> The control may be deactivated.</p>

NOTE: Even when rain drops are wiped off, remaining thin layer of water may cause smeared spots.
