Subject: <p style="text-align: center;">DIRT ACCUMULATION ON SIDE SILL</p>	Bulletin No: 09-044/06
	Last Issued: 11/03/2006

2007 CX-7 vehicles with VINs lower than JM3ER****7*138083 (produced before September 11, 2006)

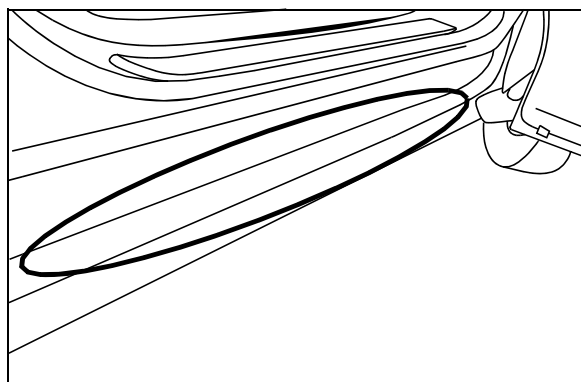
1720a

On some vehicles, dirt or debris may accumulate on the side sill and get the customer's clothing dirty when they enter or exit the front or rear doors of the vehicle.

Due to the shape of the rubber seal attached to the side step, dust may easily enter the side sill area and accumulate there.

1. Verify customer concern.
2. Replace both left and right side steps with modified parts.
NOTE: Side step covers front and rear door side sill areas.
3. Verify repair.

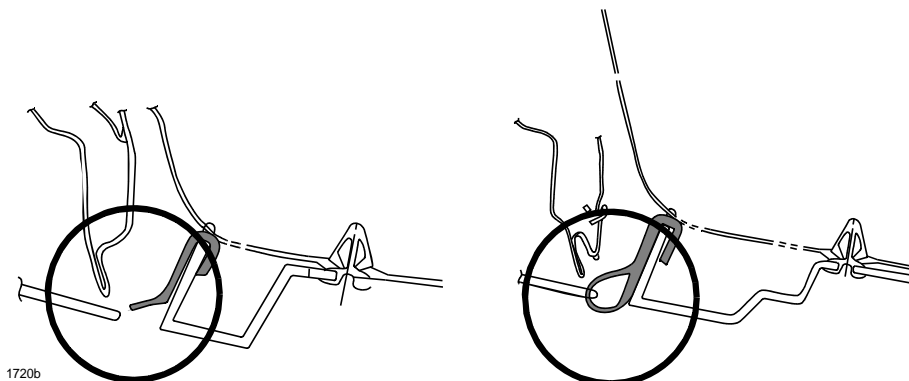
1720b

The shape of the rubber seal has been changed during mass-production.

CURRENT TYPE

NEW TYPE
