<b>Subject:</b> <b>ROUGH IDLE, LACK OF POWER, AND/OR MIL ON WITH DTC P2177/P2187 (FUEL SYSTEM LEAN)</b>	<b>Bulletin No:</b> 01-022/08 <b>Last Issued:</b> 04/02/2008
--	---

2007-2008 Mazdaspeed3 vehicles with VINs lower than JM1BK\*\*\*\* \*\* 859606 (produced before November 22, 2007)

2006-2007 Mazdaspeed6 vehicles

2007-2008 CX-7 vehicles with VINs lower than JM3ER\*\*\*\* \*\* 196510 (produced before November 19, 2007)

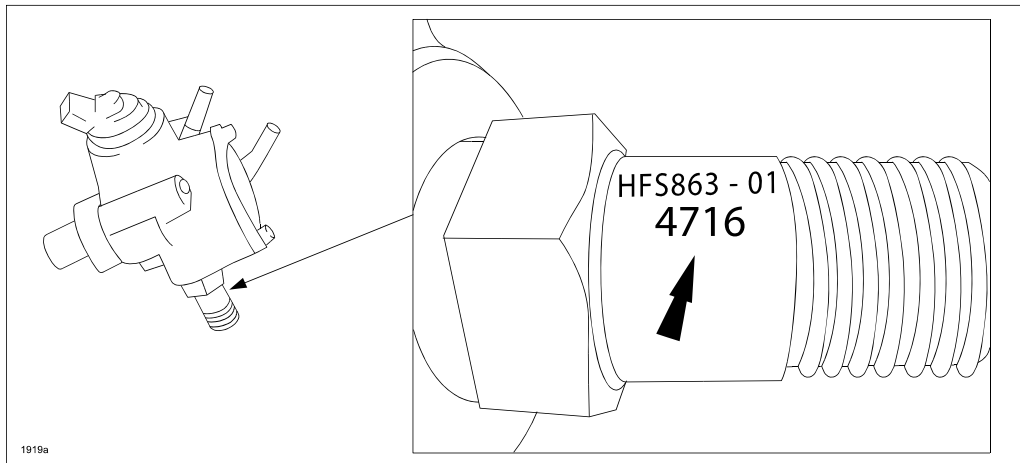
Date of production is marked as a 4 digit code “YMDD” at the pipe.

Y for Year	4 for 2004....7 for 2007
M for Month	1 for Jan....9 for Sept, X for October, Y for Nov, Z for Dec
DD for Date	01 for 1st of month....31 for 31st of month
Example	“4Z16” means Dec 16, 2004; 7608 means June 8, 2007

- If the history indicates part number L3K9-13-35ZB was used during a repair, use the following illustration to inspect the production date of the high-pressure fuel pump. Replace it if the production date is before March 26, 2007.
