Technical Service Bulletin

Subject: OIL SEEPAGE AT ENGINE FRONT COVER	Bulletin No.: 01-005/17
	Last Issued: 03/03/2017

APPLICABLE MODEL(S)/VINS

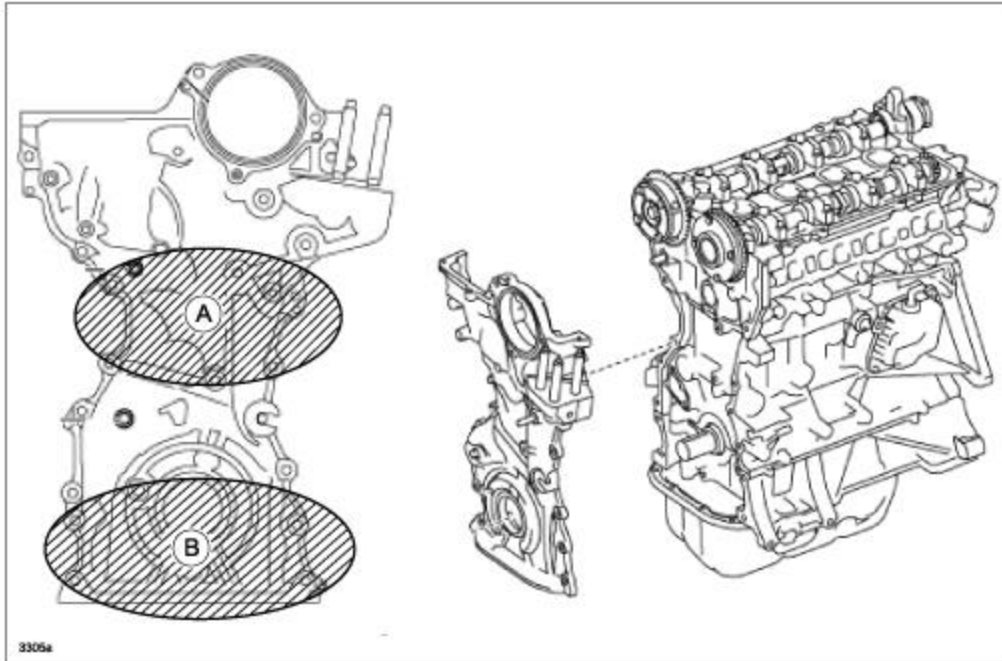
Some vehicles may exhibit oil residue on the engine front cover from seepage around the joint portion (A) between the cylinder block and head. It becomes very noticable with dust adhesion. In some cases, the area of oil residue extends down to around the joint portion (B) between the engine front cover and the oil pan.

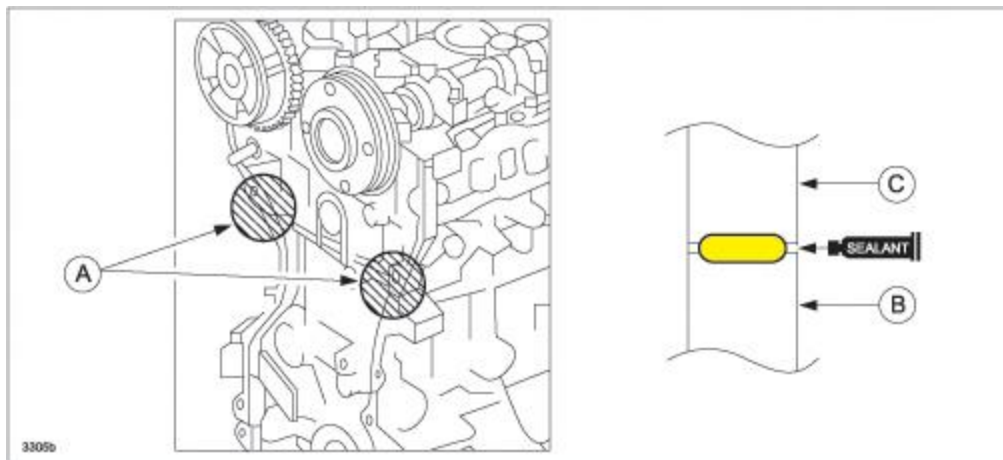
This may be caused by oil escaping from a fine clearance created at the sealant applied to joint (A) between the cylinder block (B) and head (C) when the engine was pressurized during leak testing on the engine assembly line.
