Category BODY AND ACCESSORIES	Technical Service Bulletin - Repair Guide	Ref. No. R025/18	Page 1 / 7
Applicable Model Mazda6 (Mazda6 (GJ/GL))		Date Issued May 14, 2018	
		Date Revised Feb 26, 2021

Subject: : Mazda6 (GL) - Power Outer Mirror does not fold in

Mazda6 (GL) with power folding mirrors

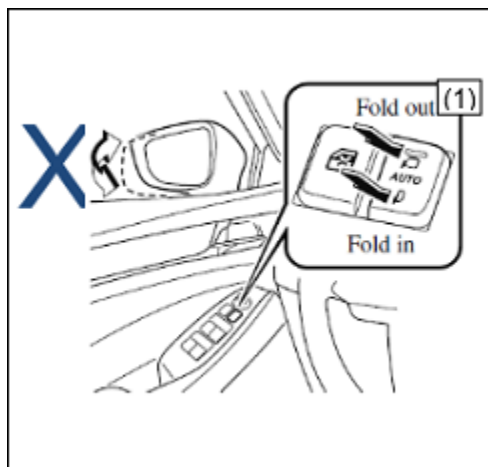
Some vehicles may exhibit a condition where the power outer mirror will not fold in and/or out when the outer mirror holding switch (1) is operated.

1. The electric fold-in unit inside the outer mirror may be corrosion-damaged by water entry due to insufficient water tightness.
2. The electric fold-in unit interferes with the outer mirror frame due to improper installation of the electric fold-in unit.
3. Friction around the shaft of the folding mechanism may increase.

If the customer concern has been reproduced, replace the electric fold-in unit with a modified one using the following procedure.

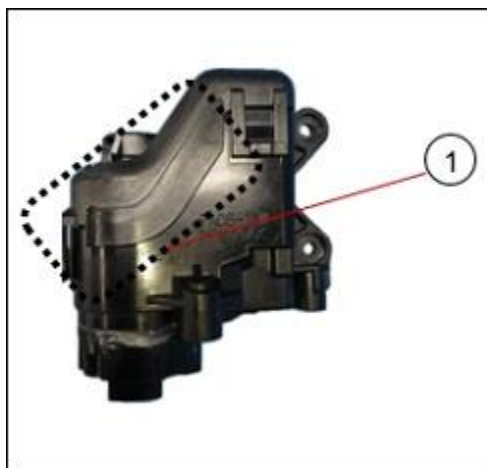
1. Overlapping part of the water-proof sealing inside the electric fold-in unit (it cannot be seen from outside) has been extended. Also, flange (1) has been attached instead of a water proof seal.
