Service Bulletin

Subject: FRONT POWER SEATS DO NOT SLIDE BACK AND FORTH	Bulletin No: 09-006/16
	Last Issued: 02/03/2016

2013-2016 CX-5 vehicles with VINs lower than JM3KE*****663237 (produced before May 1, 2015)

2014-2016 Mazda6 vehicles with VINs lower than JM1GJ*****430009 (produced before May 1, 2015)

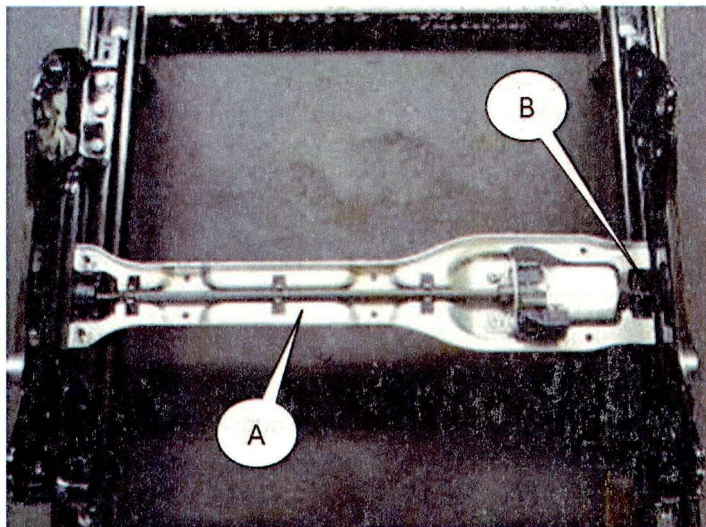
Power Slide Unit

Some customers may complain that the front power (driver and/or passenger) seats do not slide back and forth properly or that they may be completely inoperative. This concern may be caused by a foreign object getting stuck under the power slide unit (below) while in operation. This can cause motor mounting bracket (A) deformation, resulting in motor cable (B) breakage.

To eliminate this concern, the shape of the motor mounting bracket (A) has been modified to increase its strength.

1. Verify the customer concern.
2. Inspect the motor cable (short one) and the motor mounting bracket:
 - Is the motor cable broken?
 - Is the motor mounting bracket deformed?
3. If the results are "Yes" for either of the above inspections, replace the power slide unit with a newly established modified service part according to the replacement procedure.
