Technical Service Bulletin

EXCESSIVE OPERATING NOISE WHEN SLIDING POWER SEAT

Bulletin No.: 09-011/17

2014-2017 Mazda6 vehicles equipped with power seats

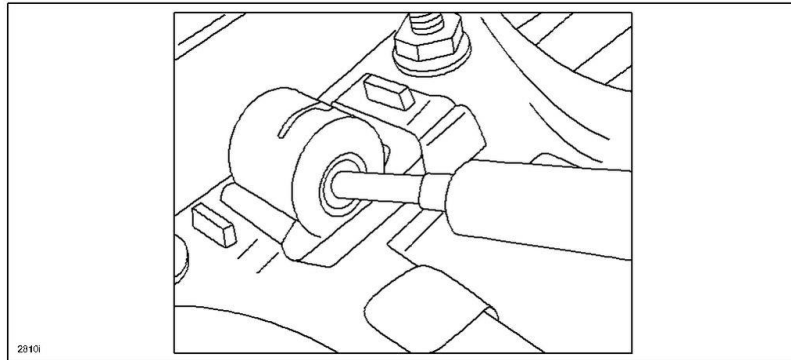
- If the cable is bent too much during installation, operation noise may occur. DO NOT hold the cable around the tip.
