09-011/17 - EXCESSIVE OPERATING NOISE WHEN SLIDING POWER SEAT

TSB NUMBER: 09-011/17

04/11/2017

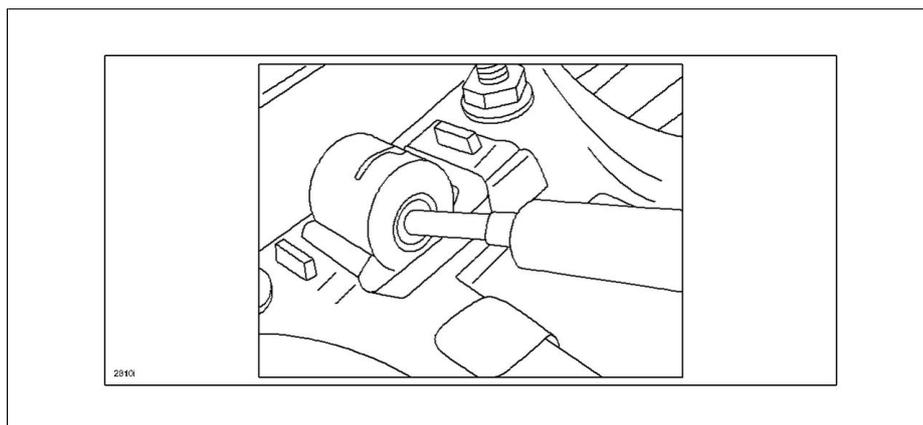
- If the cable is bent too much during installation, operation noise may occur. DO NOT hold the cable around the tip.

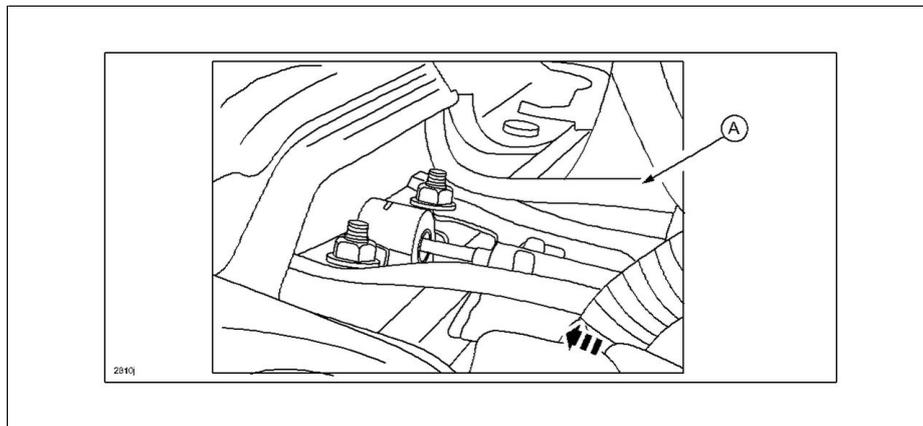
- If work space is too dark to see properly, use a light to illuminate the spot where the cable should be installed.
- Take caution not to pinch the seat belt buckle harness (A).
