Service Information

Category S	Repair Guidance	Ref. No. R054/18	Page 1 of 2
Coverage <input type="checkbox"/> Distributor only <input checked="" type="checkbox"/> Please inform your dealers		Date Issued September 12, 2018	
Please convey this information to your <input type="checkbox"/> Director <input checked="" type="checkbox"/> General Manager <input checked="" type="checkbox"/> Warranty Dept. <input checked="" type="checkbox"/> Parts Dept. <input checked="" type="checkbox"/> Training Dept. <input checked="" type="checkbox"/> Field Rep.		Date Revised	
Applicable Model CX-5 (KF) with Leather Seat		Applicable Countries and/or Vehicle Specifications Worldwide

Subject: Warping Surface of Driver's Seat

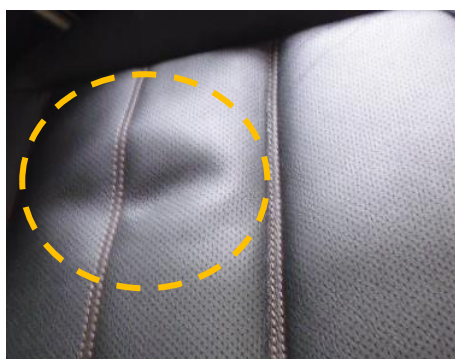
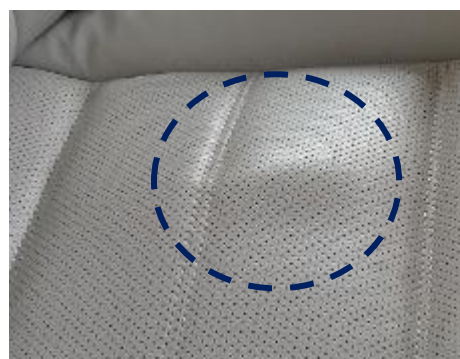
Some vehicles may exhibit a warping surface of the driver's seat cushion, which causes poor appearance.

Gap occurs between the leather surface and the cushion pad due to insufficient surface tension of the seat trim.

When you receive the customer complain on this concern, replace the front seat cushion trim(1) and the front seat cushion pad with a modified one according to the workshop manual "FRONT SEAT CUSHION TRIM REMOVAL/INSTALLATION".
