2013 - CX-5 - Body and Accessories

DECORATION PANEL REMOVAL/INSTALLATION

AUDIO UNIT REMOVAL/INSTALLATION

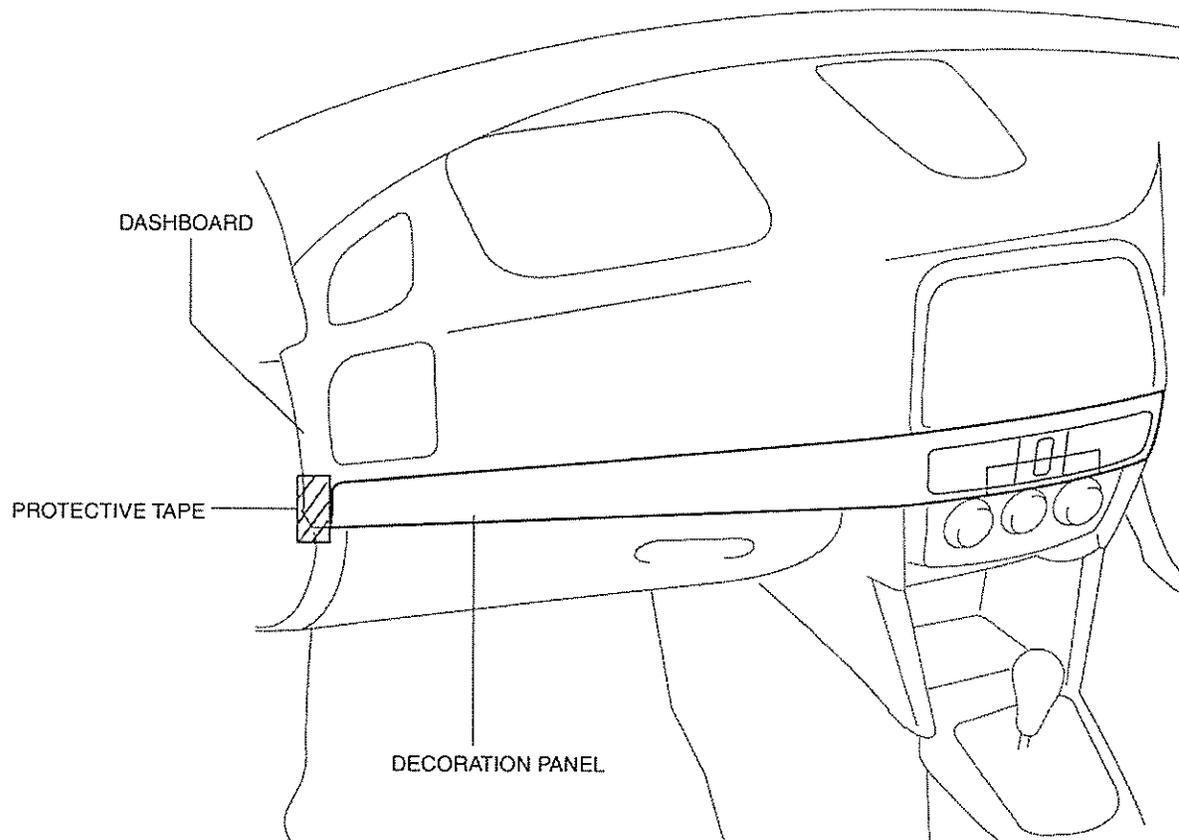
- Affix protective tape to the position shown in the figure.

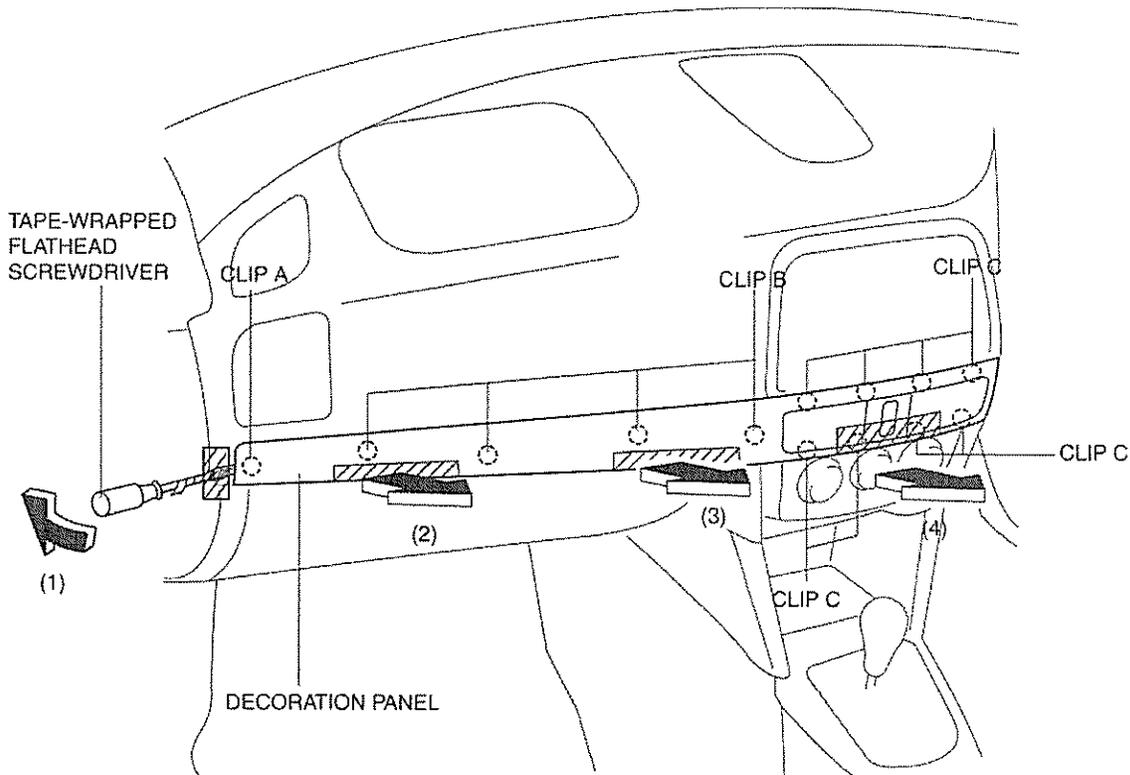
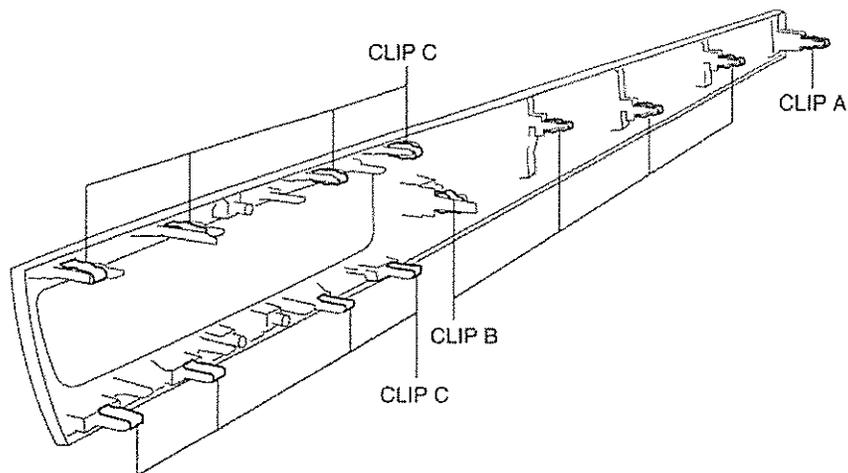
1. Disconnect the negative battery cable. (See [NEGATIVE BATTERY CABLE DISCONNECTION/CONNECTION \(SKYACTIV-G 2.0\)](#).)
2. Open the glove compartment.
3. Insert a tape-wrapped flathead screwdriver in the position indicated by the arrow (1) in the figure and detach clip A.

4. Take the shaded area shown in the figure, and remove the decoration panel in the direction of the arrow in the order of (2), (3), (4) while detaching clips B, clips C.
5. Disconnect the hazard switch connector.
6. Install in the reverse order of removal.

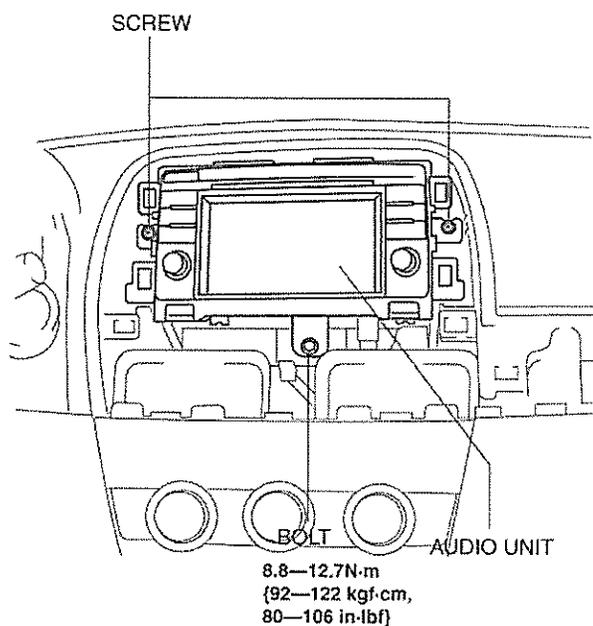
1. Disconnect the negative battery cable.
2. Remove the decoration panel. (See [DECORATION PANEL REMOVAL/INSTALLATION](#).)
3. Remove the bolt.

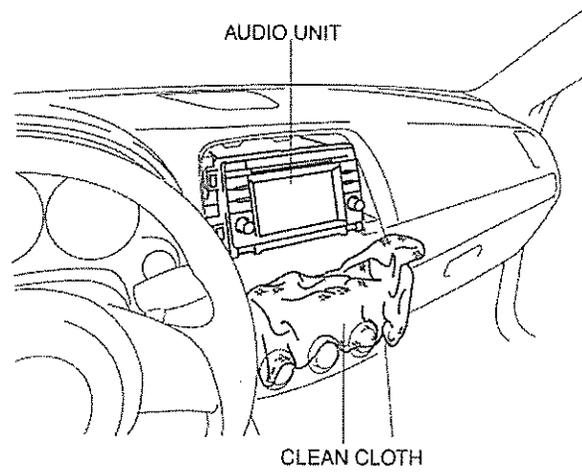
- When removing the audio unit, the audio unit could interfere with the climate control unit and scratch the climate control unit. Perform the servicing by spreading a cloth in the position indicated in the figure.

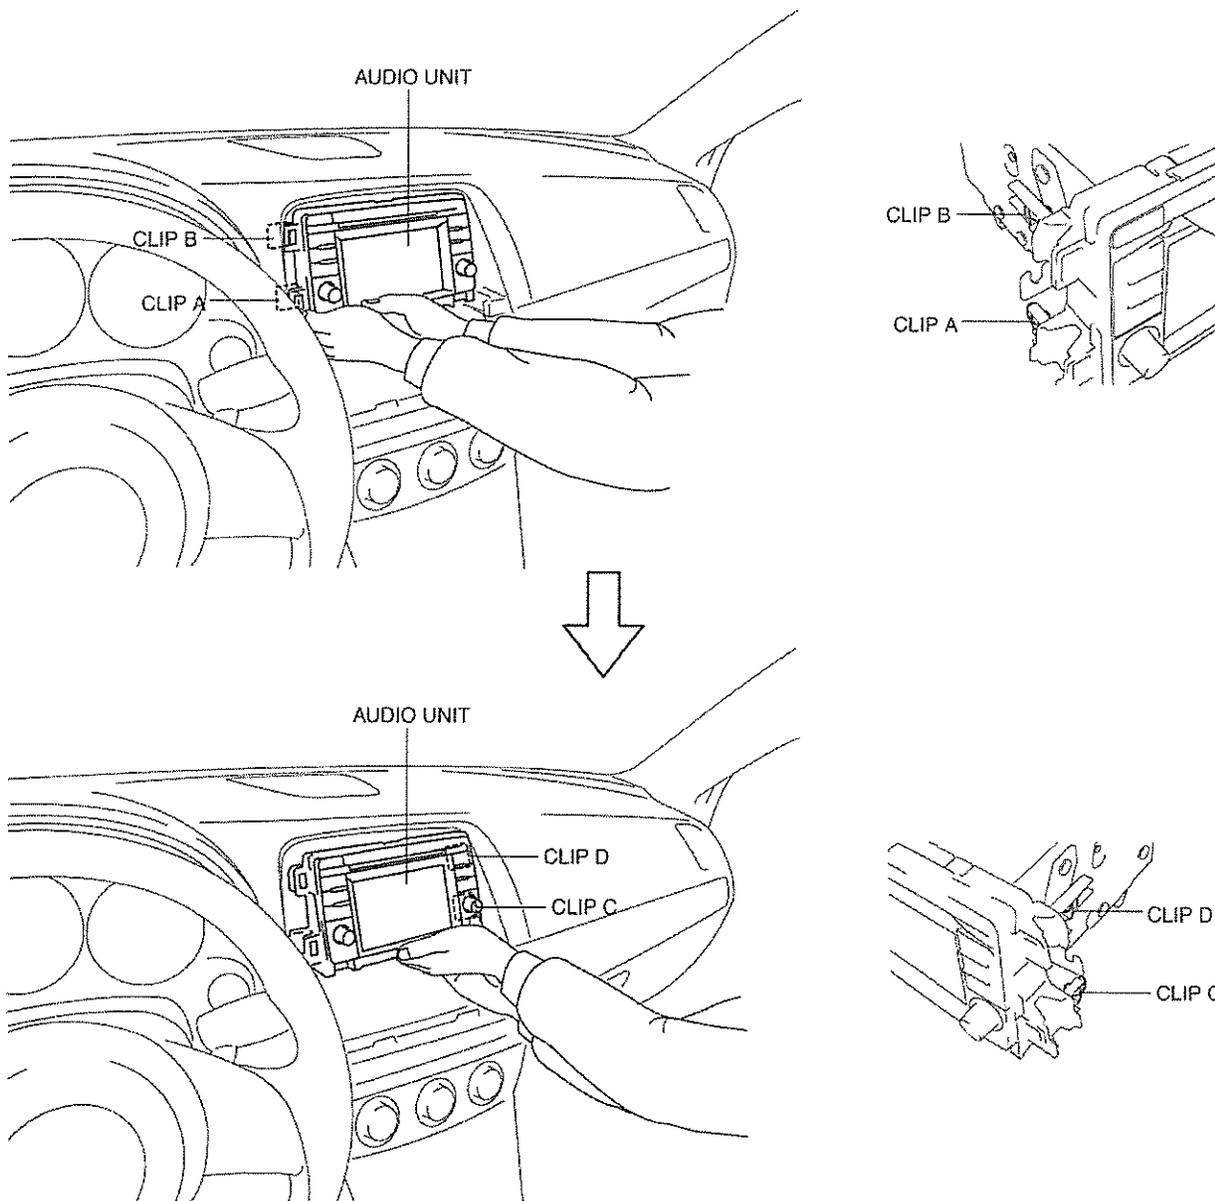
5. Hold the audio unit in the position shown in the figure and pull it outward to disengage clips A, B, C, and D from the instrument panel.

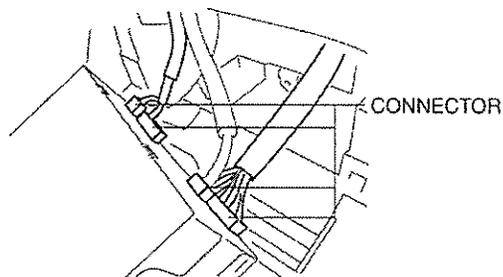
WITHOUT COLOR LCD

6. Disconnect the connectors.

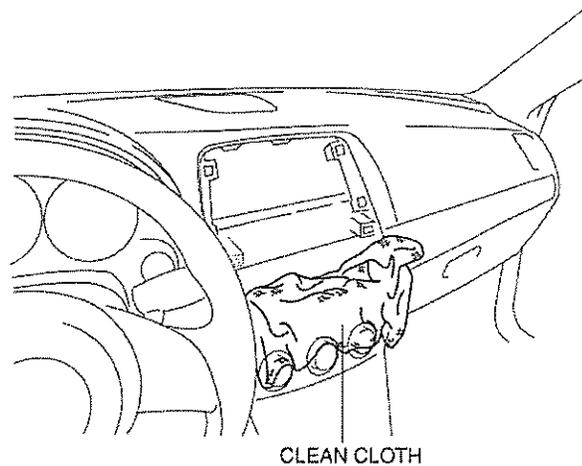
- When installing the audio unit, the audio unit could interfere with the climate control unit and scratch the climate control unit. Perform the servicing by spreading a cloth in the position indicated in the figure.

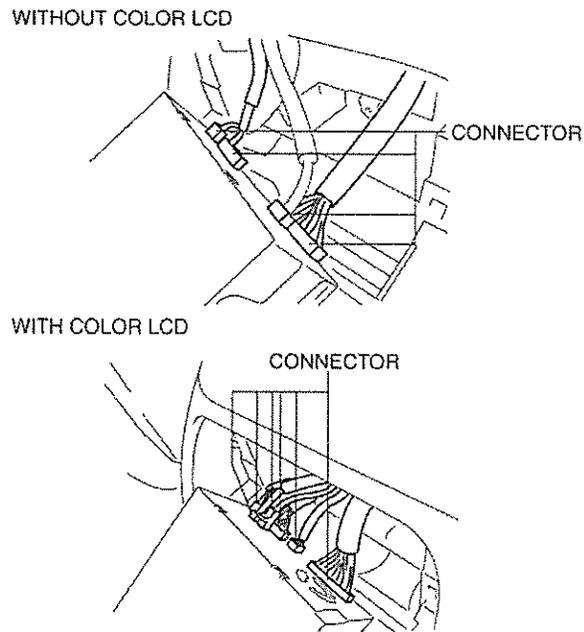
1. Connect all the connectors.

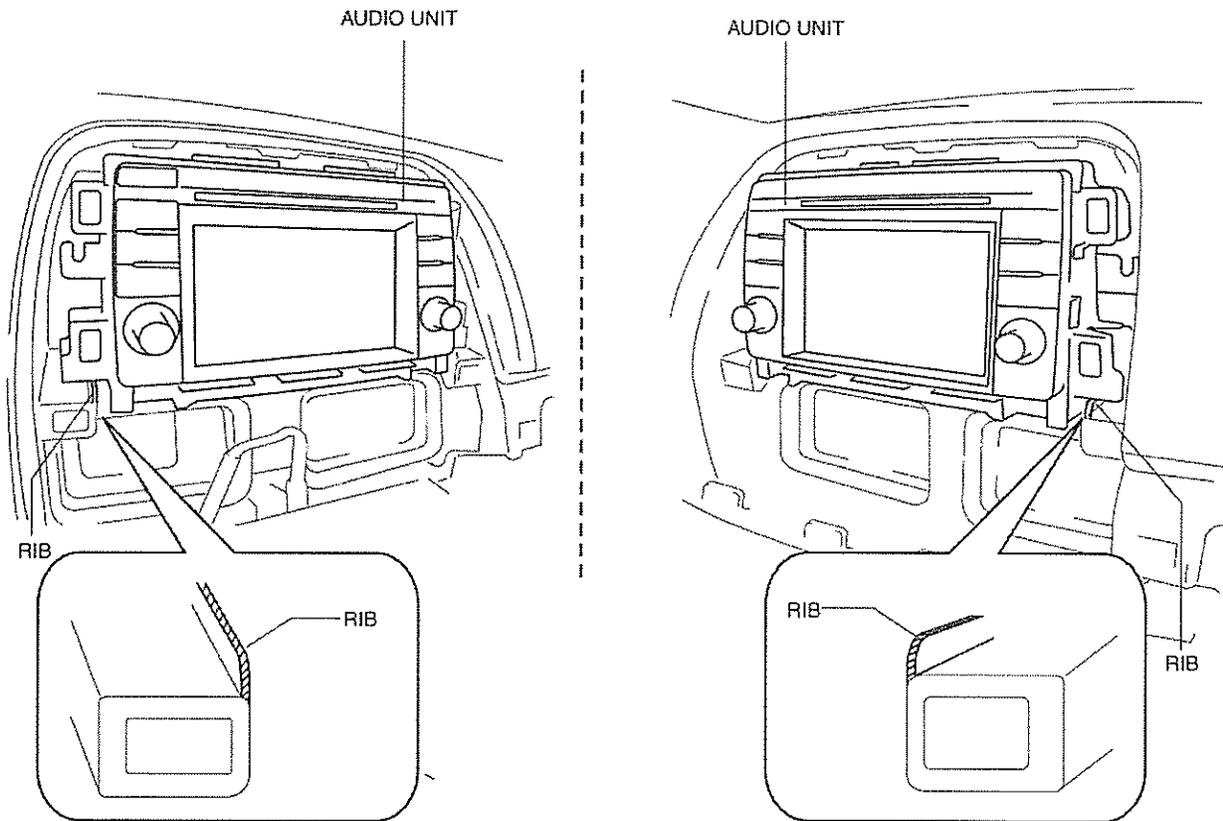
2. Temporarily position the audio unit on the ribs and align the hole positions of the instrument panel with clips.

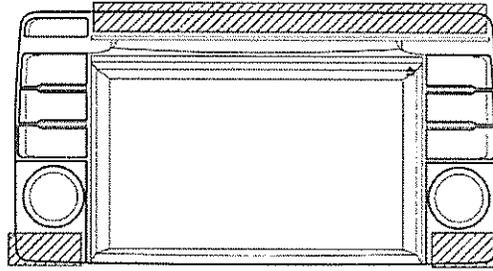
WITH COLOR DISPLAY

3. Press the audio unit in the position shown in the figure and engage clips to the instrument panel.

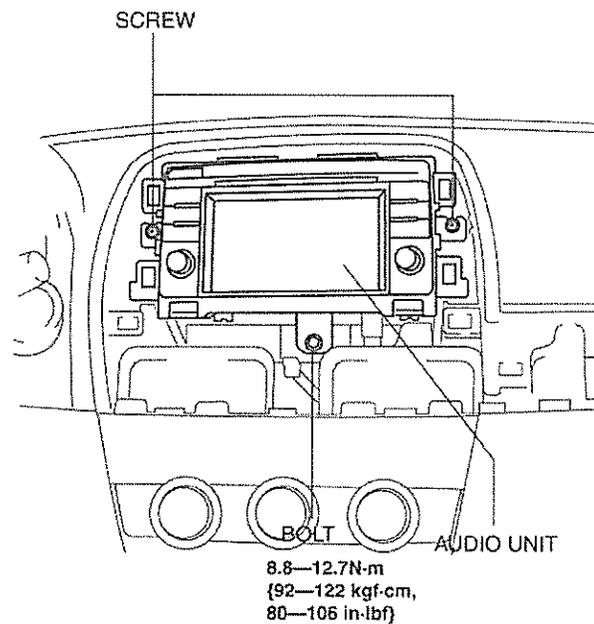
4. Install the screws.
