Technical Service Bulletin

**KNOCKING / SQUEAKING NOISE FROM FRONT SHOCK ABSORBER,
CREAKING NOISE FROM FRONT LOWER ARM BUSHING**

Bulletin No.: 02-002/18

Last Issued: 01/05/2018

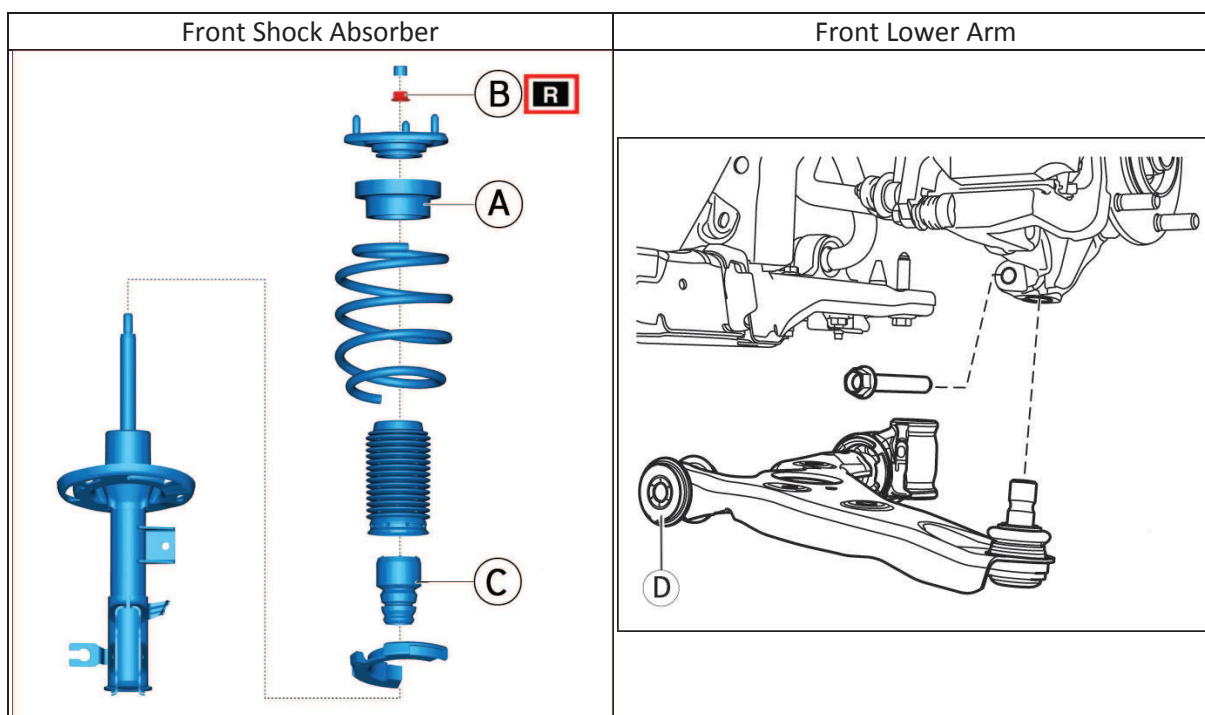
Some vehicles may exhibit a knocking / squeaking noise from the front shock absorber when driving on rough roads and/or when turning the steering wheel while the vehicle is stopped.

The noise may be due to:

- Upper front strut bearing (A) damage. (CX-5 and Mazda6)
- Squeak type noise between the front strut bearing and coil spring. (CX-3, CX-5 and Mazda6)
- The bump stopper (C) may be contacting the strut bearing when the front shock absorber is compressed, causing a popping noise. (Mazda6 only)
- The front lower arm bushing (D) is making a creak type noise in wet road conditions. (CX-5 and Mazda6).

To eliminate the noise, the following mass-production changes have been made:

1. The material and production method of the front strut bearing (A) has been changed. (CX-5 and Mazda6)
2. A protector has been installed onto the coil spring. (CX-5 and Mazda6)
3. The shape of the bump stopper (C) will be modified in the future. (Mazda6 only)
4. The shape of the coil spring has been changed. (CX-3 only)
5. Friction of the lower arm bushing has been reduced by adding a dry coating. (CX-5 and Mazda6).

NOTE: The piston rod nut (B) requires replacement.

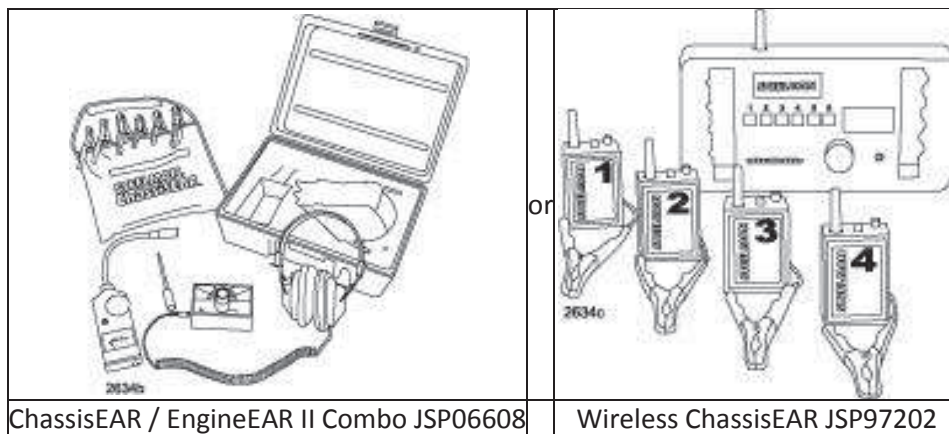
1. Use Special Service Tool (SST) ChassisEAR / EngineEAR II Combo JSP06608 or Wireless ChassisEAR JSP97202 to confirm noise is coming from the front suspension when driving over bumps and/or turning the steering wheel while the vehicle is stopped:

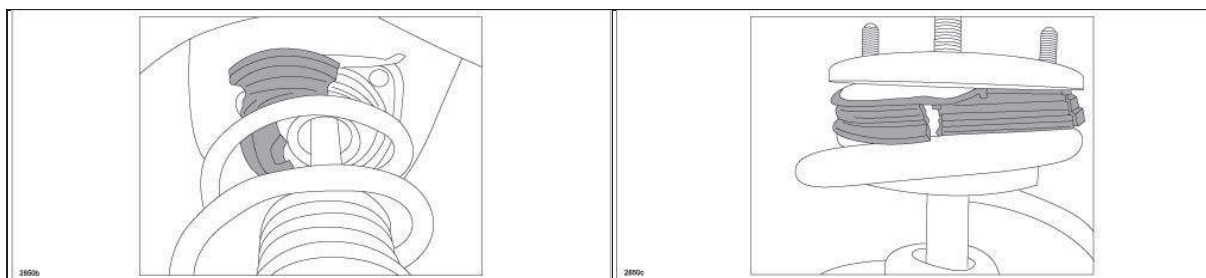
Inspect Front Strut Bearing for damage (For Vehicle Type A only)

1. Remove the front strut bearing and coil spring according to the MGSS online instructions or the Workshop Manual (section 02-13 FRONT SHOCK ABSORBER AND COIL SPRING DISASSEMBLY/ASSEMBLY).
2. Replace the front strut bearing if damaged*.

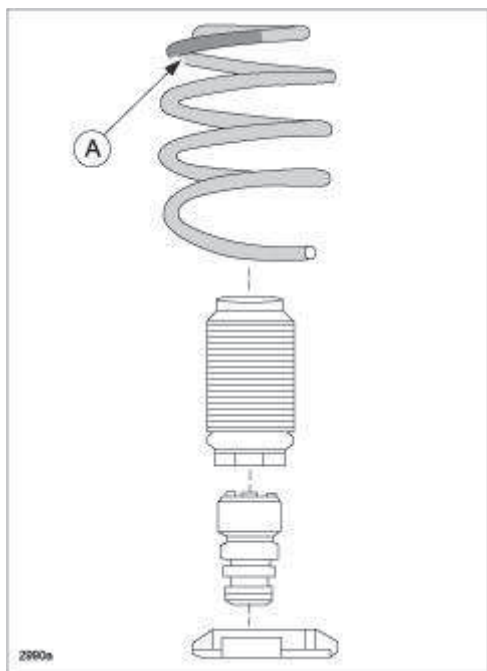
Coil Spring Protector (A) Installation:

Install Protector onto Coil Spring (For Vehicle Type A, B and E)

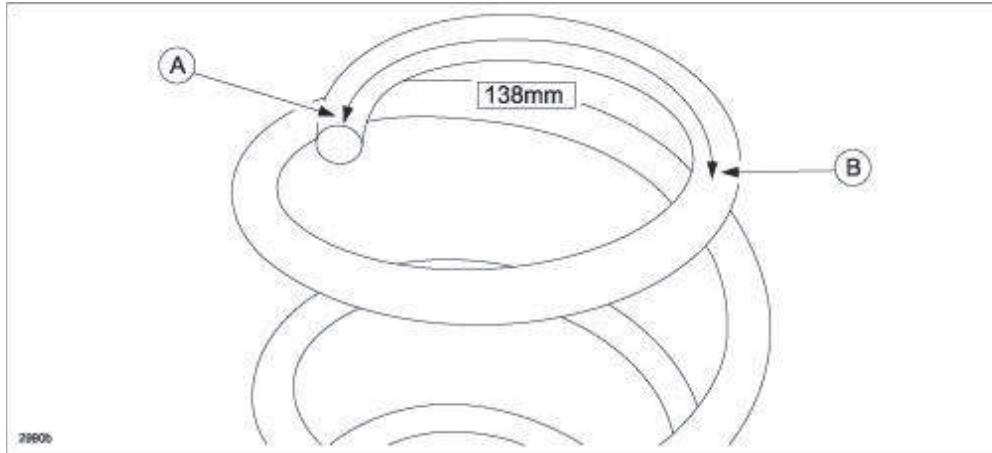
1. Starting from the top of the coil spring, decrease the spring 1.5 coils downward.
 2. Cut a thin strip of paper to 138 mm in length (or use a cloth type measuring tape).
- NOTE:** For CX-3, use 130 mm in length.
3. Place the strip of paper (or cloth measuring tape) along the inner side of the coil spring starting at point (A).
 4. Mark the spot on the spring where (B) is. (B) is the starting point for the protector installation.

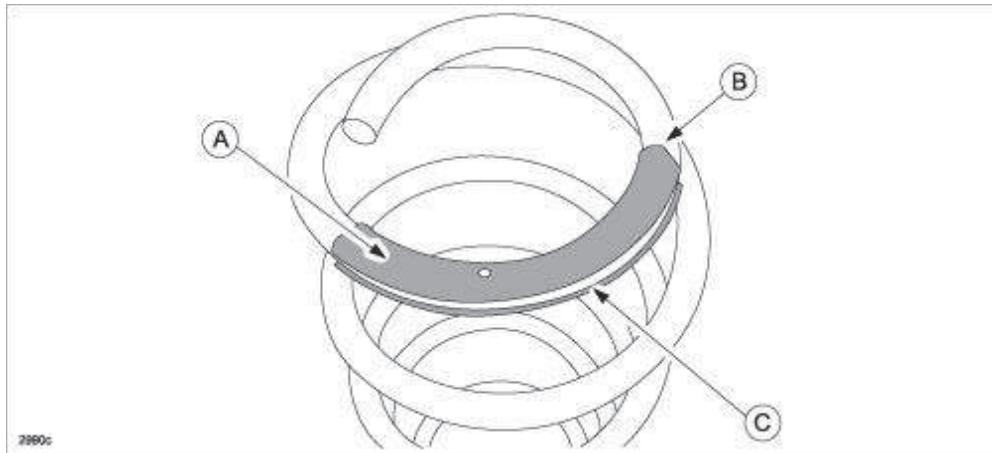
5. Install the protector (A) onto the coil spring aligning the end (slant cut side) with the marking at spot (B).
- NOTE:** Install the protector so the gap (C) is evenly aligned around the outer edge of the coil spring.

6. The inner side of the protector contains adhesive glue. After installing the protector onto the spring, press the inner side to firmly adhere it to the spring.
7. Assemble the coil spring to the strut assembly and make sure the protector is seated onto the bearing even when the shock absorber is fully extended.

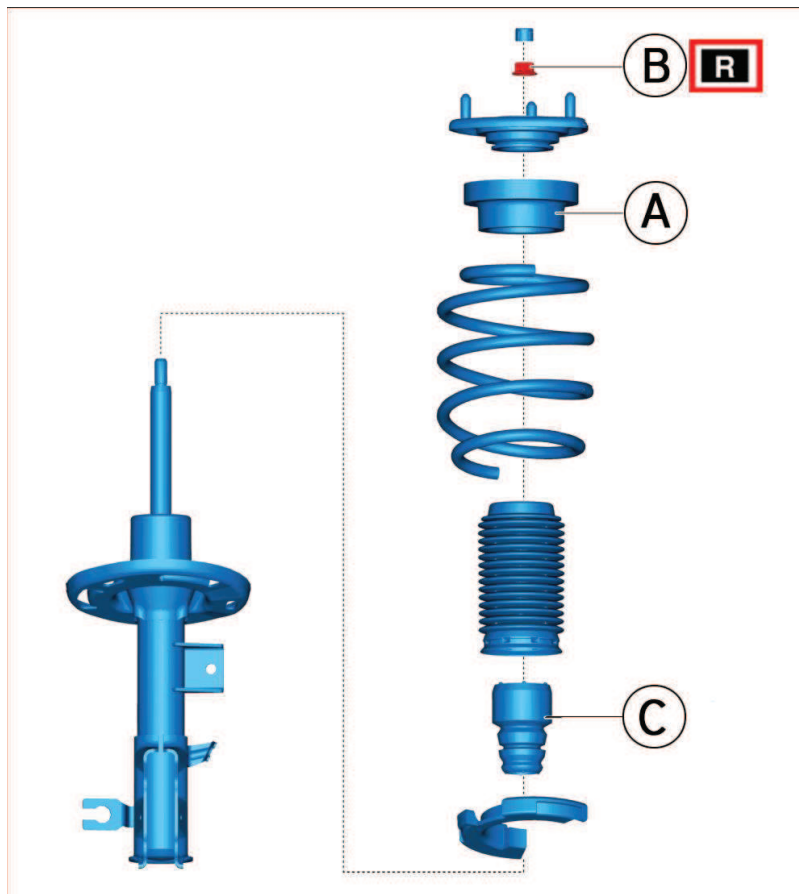
Replace Bump Stopper (For all Mazda6 vehicles, Type D)

1. Remove the front strut bearing and coil spring according to MGSS online instructions or the Workshop Manual (section 02-13 FRONT SHOCK ABSORBER AND COIL SPRING DISASSEMBLY/ASSEMBLY).
2. Replace the bump stopper (C).

3. Reinstall the front strut bearing and coil spring according to MGSS online instructions or the Workshop Manual (section 02-13 FRONT SHOCK ABSORBER AND COIL SPRING DISASSEMBLY/ASSEMBLY).
4. Repeat Steps 1 - 3 on the opposite side front suspension.
5. Verify repair.

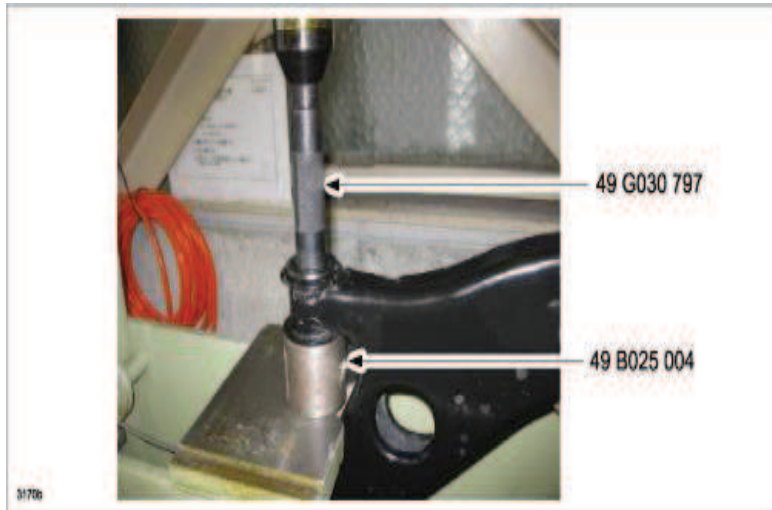
1. Remove the front lower arm (both sides) according to MGSS online instructions or the Workshop Manual (section 02-13 FRONT LOWER ARM REMOVAL/INSTALLATION).
2. Remove the front lower arm bushing using the SSTs.

Set SSTs [49 G030 797 and 49 B025 004] and the front lower arm on a shop press as shown in the figure and remove the front lower arm bushing.

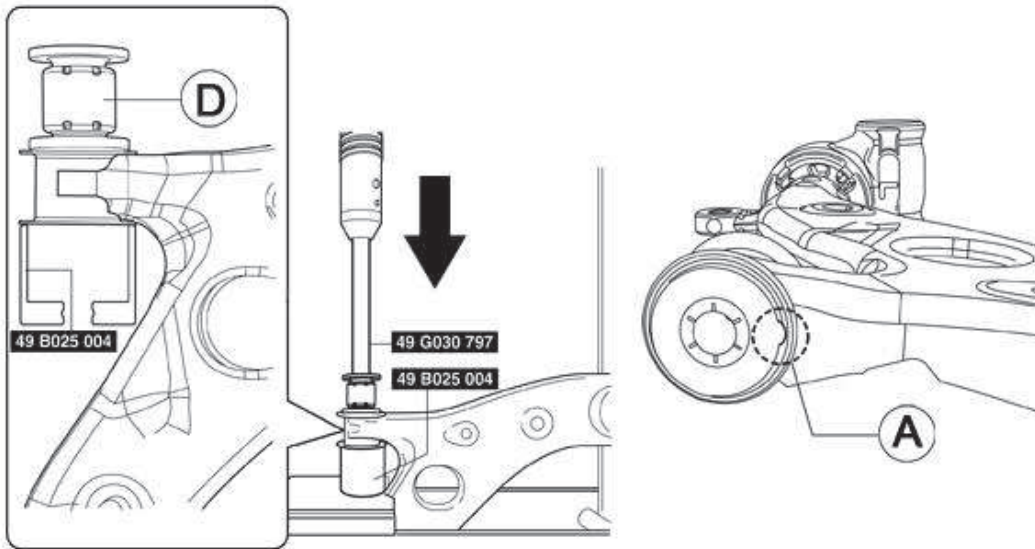
3. Install the front lower arm bushing (D) using SSTs.

1. Early front lower arm bushing (D) service part has a projection (A). Install the front lower arm bushing so that the projection (A) shown in the figure is pointing toward the front and out of the vehicle.
2. Current front lower arm bushing (D) service part does not have a projection (A) and can be installed in either direction.

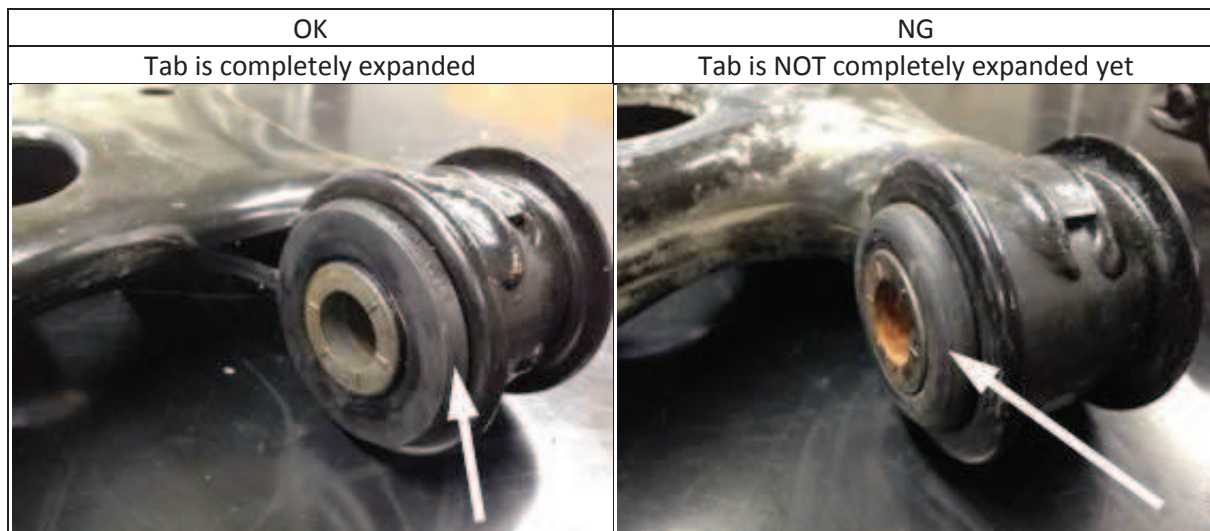
CAUTION: Make sure that the bushing has been properly inserted by checking that the tab of the bushing is completely expanded as shown in the OK illustration.

- Before installing the new bushing, wipe the inside of the outer tube and make sure it is clean.
- Apply soap suds to the front lower arm bushing to facilitate installation.
- If soap suds gets in the inner pipe of the front lower arm bushing, always wipe it off using a cloth.

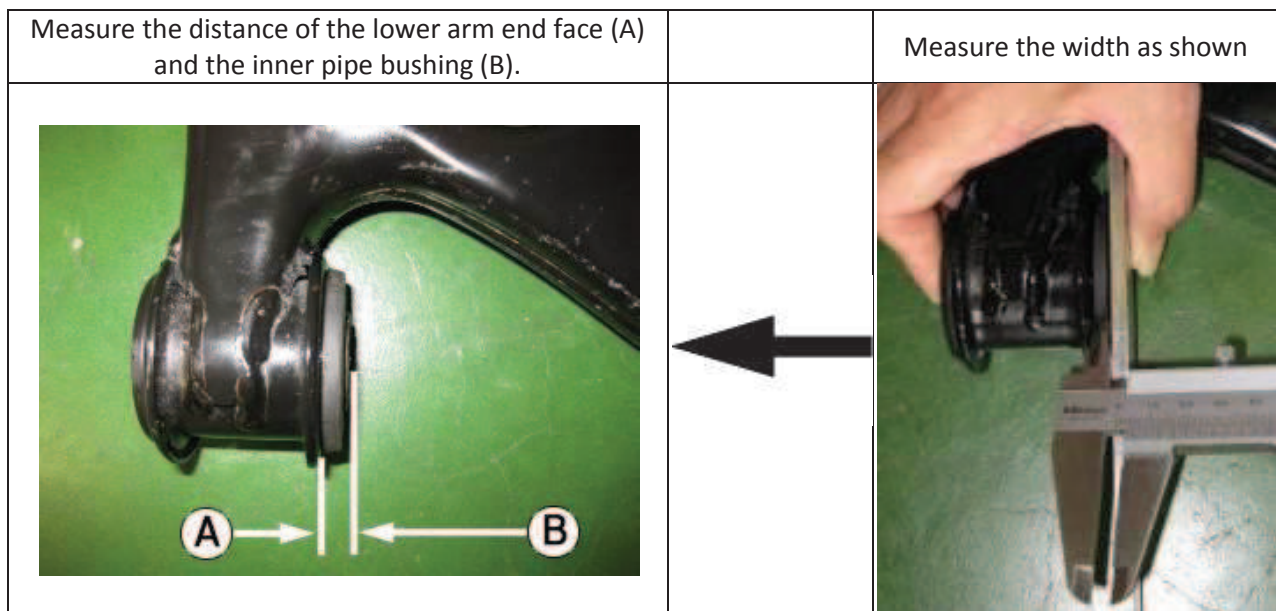
4. After the installation, verify that the front lower arm bushing has been installed to the correct position by the procedure shown in the figure.

Specification: Width: 5.6 +/- 0.8mm (0.22 +/- 0.03 in)

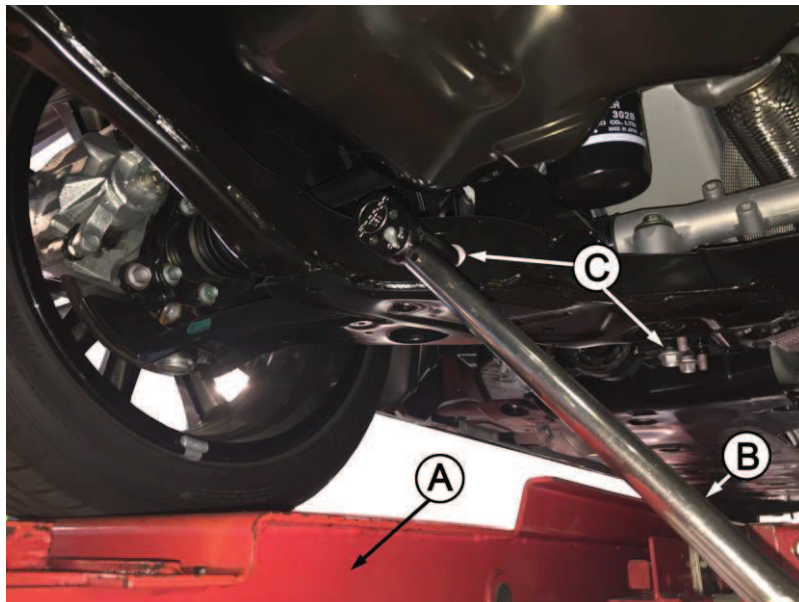
NOTE: For the joint sections with rubber bushings, raise the vehicle using a lift, and then temporarily tighten the installation bolts. Then raise the vehicle using a wheel alignment lift rack (A) or lower the vehicle to the ground (to load the suspension). Use a torque wrench (B) to tighten the bolts (C) to the specified tightening torque. The Mazda6 is shown below as an example.

5. Install the front lower arm (both sides) according to MGSS online instructions or the Workshop Manual (section 02-13 FRONT LOWER ARM REMOVAL/INSTALLATION).
