Service Information

Mazda Motor Corporation

Category T	Repair Guidance	Ref. No. R046/17A	Page 1 of 4
Coverage <input type="checkbox"/> Distributor only <input checked="" type="checkbox"/> Please inform your dealers		Date Issued June 28, 2017	
Please convey this information to your <input type="checkbox"/> Director <input checked="" type="checkbox"/> General Manager <input checked="" type="checkbox"/> Warranty Dept. <input checked="" type="checkbox"/> Parts Dept. <input checked="" type="checkbox"/> Training Dept. <input checked="" type="checkbox"/> Field Rep.		Date Revised August 2, 2017	
Applicable Model and Equipment Mazda3 (BN), Mazda6 (GL), CX-3 (DK) and CX-5 (KF)		Applicable Countries and/or Vehicle Specifications Worldwide

Subject: Forward Sensing Camera (FSC) related concerns with DTC C1001:92

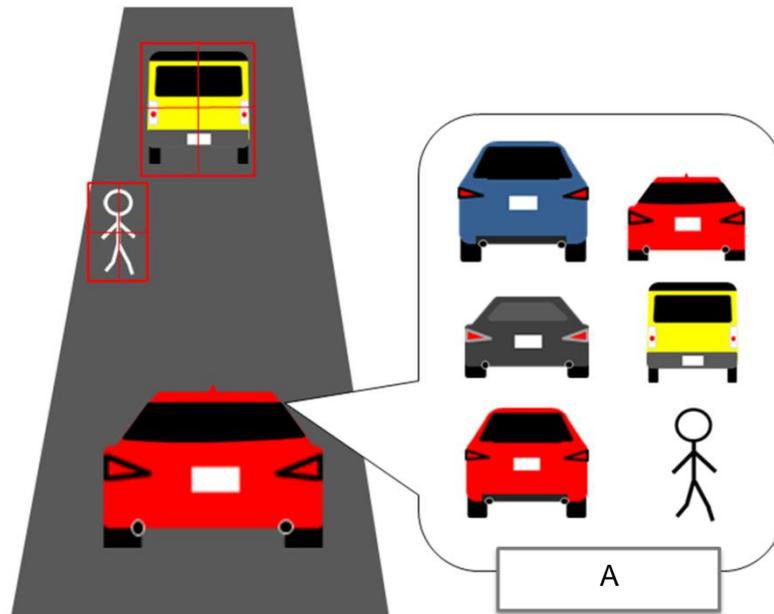
1. Forward Sensing Camera system

The Forward Sensing Camera recognizes objects comparing the characteristics of captured images to pre-defined data (A) for vehicles and pedestrians.

FSC is located at interior side of upper center of the windshield. Mazda employs single camera system while some brands employ stereo camera system. Generally the single camera is located closer to the windshield than the stereo camera. Each system has advantage and disadvantage.
