Technical Service Bulletin

Subject: OIL SEEPAGE AT ENGINE FRONT COVER	Bulletin No.: 01-005/17
	Last Issued: 03/03/2017

APPLICABLE MODEL(S)/VINS

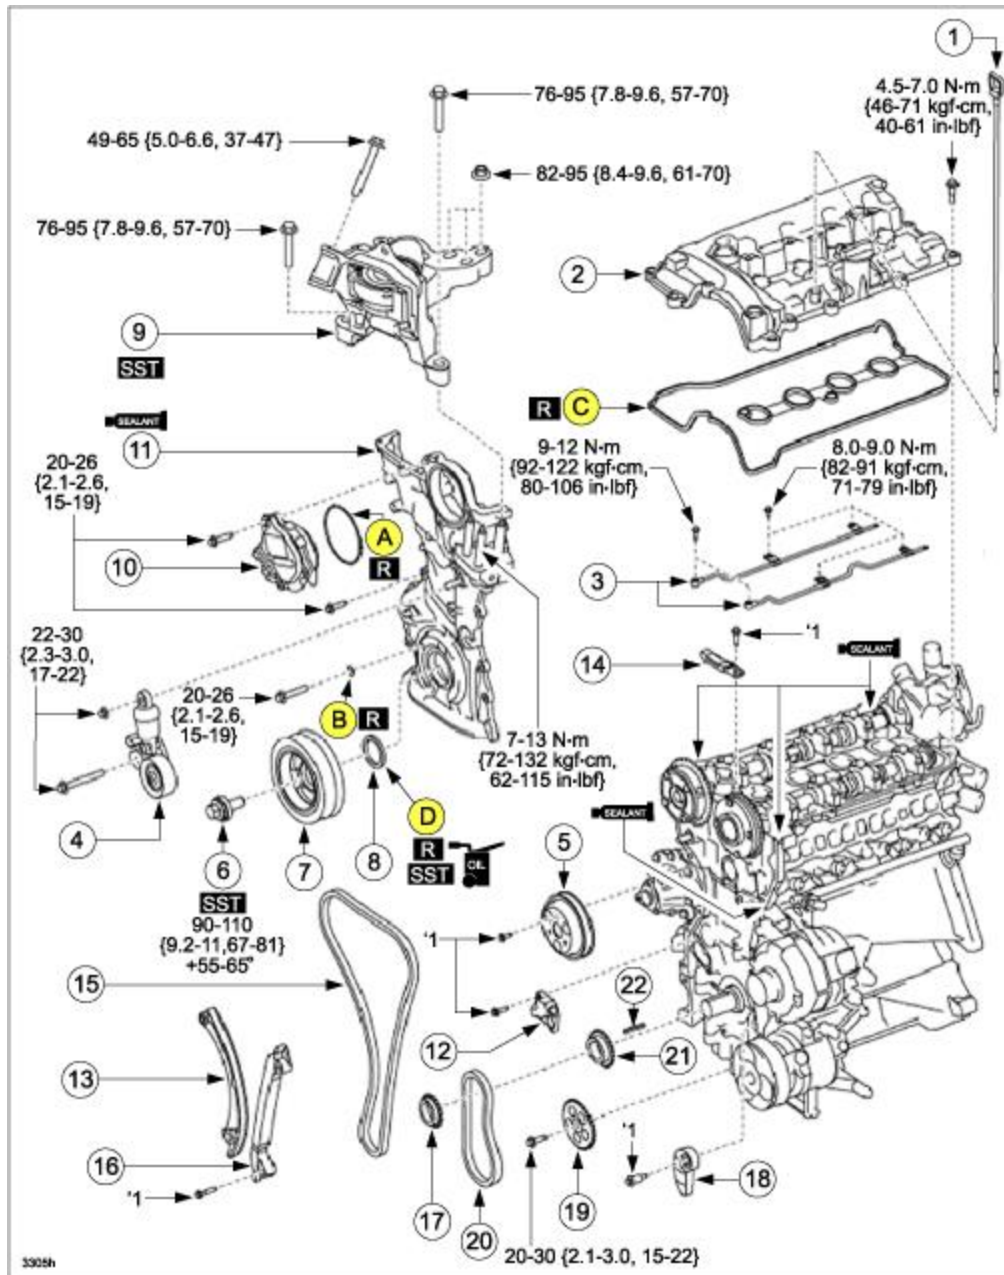
PARTS LOCATION

1. Dipstick	7. Crankshaft pulley
2. Cylinder head cover	8. Front oil seal
3. Oil shower pipe	9. No. 3 engine mount
4. Drive belt auto tensioner	10. Electric variable valve timing motor/driver
