Category BODY AND ACCESSORIES	Technical Service Bulletin - Repair Guide	Ref. No. R025/18	Page 1 / 7
Applicable Model Mazda6 (Mazda6 (GJ/GL))		Date Issued May 14, 2018	
		Date Revised Feb 26, 2021

Subject: : Mazda6 (GL) - Power Outer Mirror does not fold in

Mazda6 (GL) with power folding mirrors

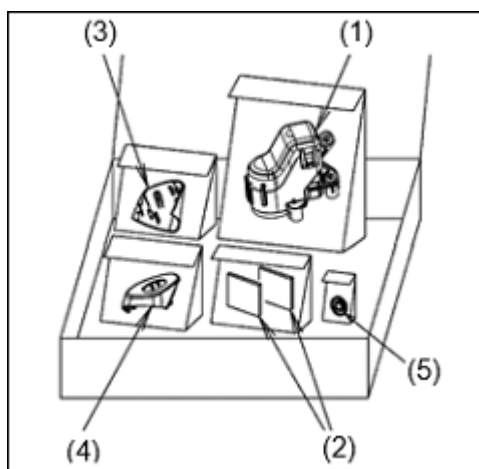
NOTE: The kit includes the following parts.

1. Electric Fold-in Unit
2. Seal Packing (2)
3. Base Cover #1
4. Base Cover #2
5. Push Nut
