Service Bulletin

Subject: FRONT POWER SEATS DO NOT SLIDE BACK AND FORTH	Bulletin No: 09-006/16
	Last Issued: 02/03/2016

2013-2016 CX-5 vehicles with VINs lower than JM3KE*****663237 (produced before May 1, 2015)

2014-2016 Mazda6 vehicles with VINs lower than JM1GJ*****430009 (produced before May 1, 2015)

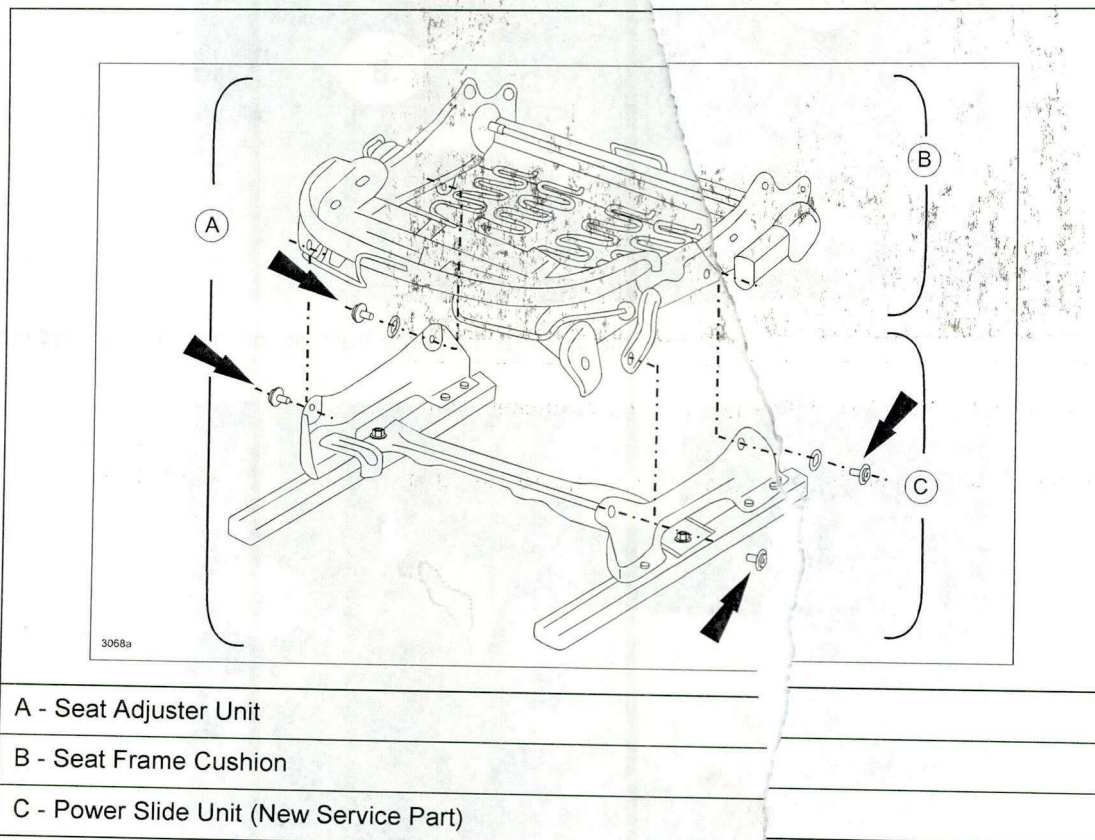
1. Verify the customer concern.
2. Inspect the motor cable (short one) and the motor mounting bracket:
 - Is the motor cable broken?
 - Is the motor mounting bracket deformed?
3. If the results are "Yes" for either of the above inspections, replace the power slide unit with a newly established modified service part according to the replacement procedure.

4. Remove the seat adjuster unit (A) according to MS3 Online or the workshop manual (section 09-13 FRONT SEAT ADJUSTER UNIT REMOVAL/INSTALLATION).
